Plant Safety Bulletin

VOLUME 2, ISSUE 2

DECEMBER 2010

Hi-rail Spring Replacements

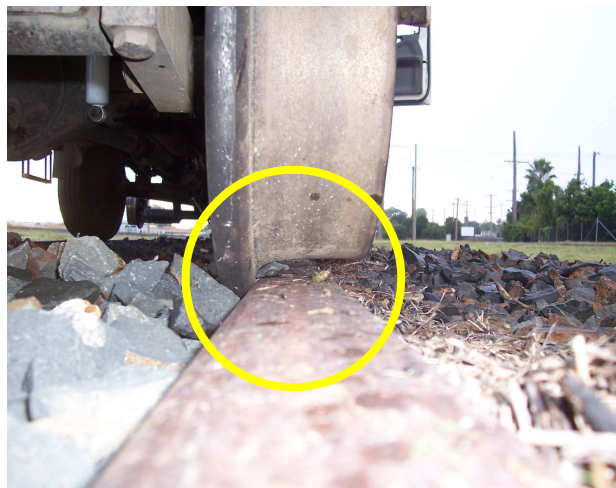
The problem arising here is the rail guidance system on the vehicle had been set up with the extra leaf spring in it. The introduction of a different spring could have caused the vehicle and rail guidance system to react in a number of ways, with the worst case scenario being vehicle derailment.

This photo clearly shows the dangers arising from not having the hi-rail guidance system recertified after having springs replaced. The hi-rail wheel has totally lost contact with the rail and would have certainly derailed had the problem not been spotted. Not all issues would be this obvious, with some wheels appearing to be on the rail, however the amount of down force on that wheel may have been severely compromised.

Caution: It is imperative that all hi-rail vehicles (utilities and trucks) that have spring repairs (leaf or coil) carried out are inspected by an ARTC approved hi-rail maintainer prior to them going back into on-track service.
