Westinghouse Signal LED Module Failure

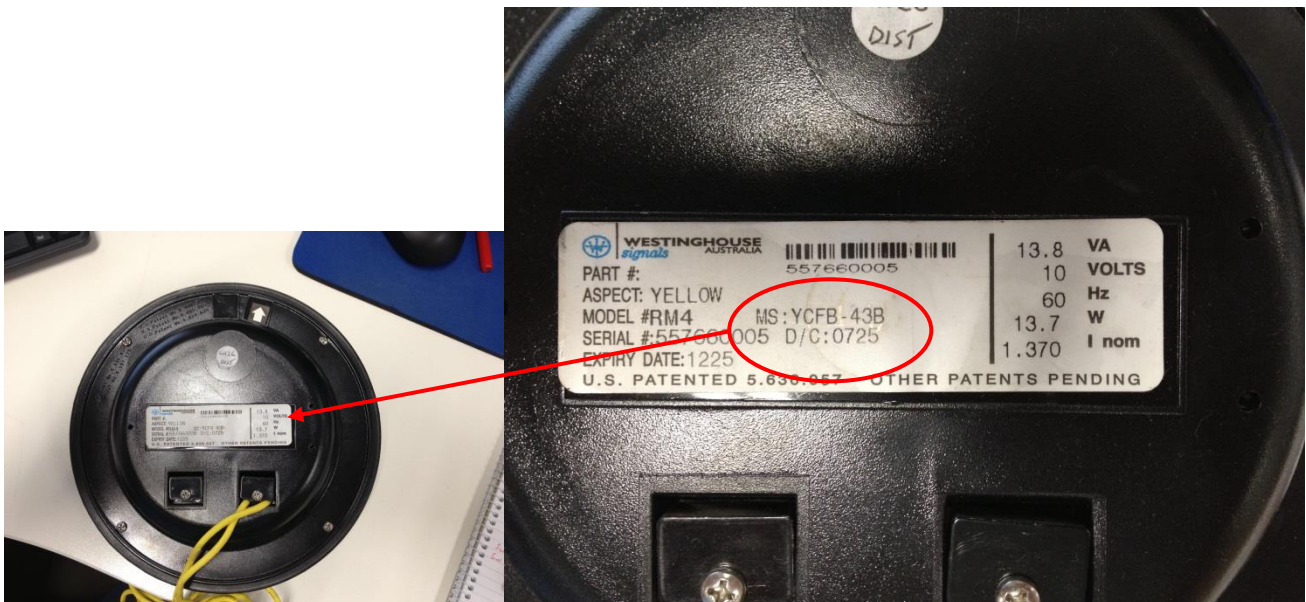
Figure 1

- 1) Inspect the Information Label fixed to the rear of the RM4 LED module (as shown in Figure1)
- 2) If the D/C (Date of Construction) number is lower / earlier than 0741 (41st week of 2007) then record the interlocking location name e.g. crossing loop name, signal number, date as shown on the label and the signal aspect i.e. Red, Yellow or Green and if the Yellow aspect has a pulsating Yellow function on the form provided in the appendix.

- 3) For YELLOW aspects the LED module should be replaced immediately or recorded as a defect and scheduled for replacement (provided sufficient spares maintained in inventory) in the Works Management System (WMS) at the earliest opportunity but no later than the next maintenance visit.
