SIGNAL ENGINEERING INSTRUCTION
April 2006
ESI 06 03N

Inspection of Point Claw Locking Brackets

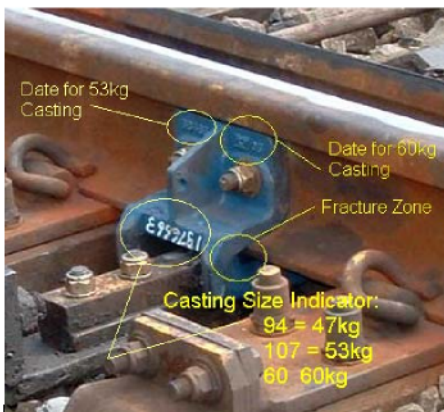
Claw Locking Bracket

The claw locking bracket for the trailing end of 699B points at Flemington, NSW was found by RailCorp to have fractured, and as a result the points could not be locked. The item was manufactured by Queensland Rail foundries in 1996, and can be identified by the casting date "QR96". The cause of the fracture is currently unknown, however, vibrations caused by squat damage to the rail head could be a contributing factor. It is also not known whether the fault is isolated, or more widespread, therefore further testing of installed locking brackets may be required.

Signal maintenance staff are to inspect claw lock brackets during their next scheduled maintenance visit. The brackets should be cleaned and visually examined around the fracture zone for any signs of fatigue or cracking. The rail head must also be checked for damage, and the casting dates for each bracket should be noted with the location, point number, point end, and rail fitted, and sent to either Peter Tobin or John Gifford. Please see above for diagrams of the locking bracket, casting number, and rail head damage.
