SIGNAL ENGINEERING INSTRUCTION
10 July 2006
ESI 06 04A

Westinghouse LED signal modules

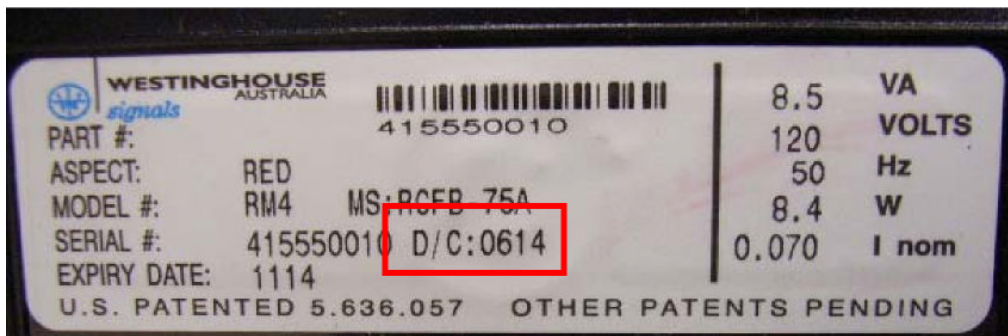
Figure 1: Example of Label

All RM4 (200 mm) LED Signal modules with a manufacturing date between 10th February 2006 and 27th April 2006. The manufacture date can be read from the label on the rear of the signal following the identifier "D/C:" This is the manufacturing date code in the form YYWW (year and week number). Affected signals could have date codes between 0606 and 0617. Some signals at the extreme of this range may be OK.

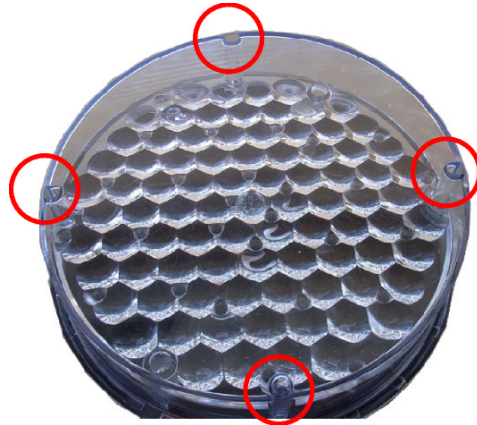
Figure 2: Signal Face showing the four pillars

The signals can be visually identified by looking at the four mounting pillars as shown in Figure 2.

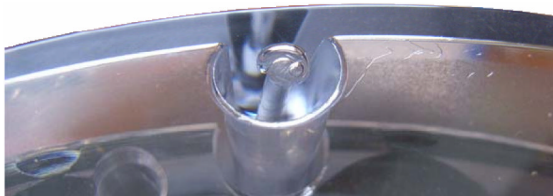
There are three versions covers manufactured recently. Signals that are not at risk have a full seal on the top of these pillars, as shown in Figure 3 and Figure 4

Figure 3: Older cover, with full surface seal

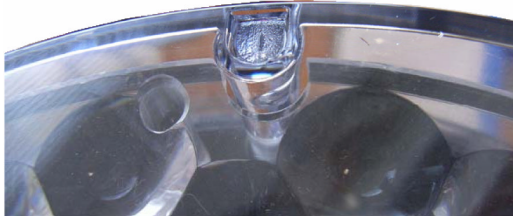
Figure 4: Latest cover with slightly recessed Seal.

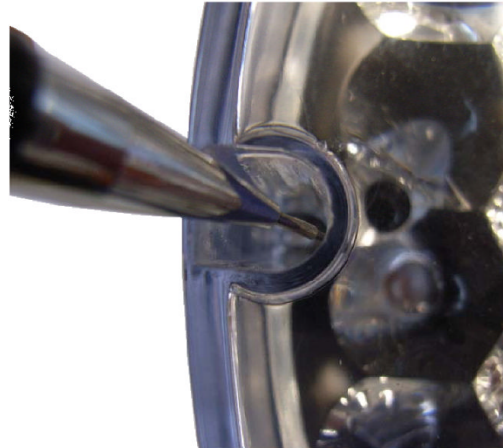
Figure 5: At risk covers, not moulded to the top.

Affected covers have the seal well down in the pillar. Figure 5 shows an example where a pencil can be inserted from the front of the cover. These are the only signals that need attention.

Some of the front clear polycarbonate covers manufactured in this time may have microscopic cracks around the screw assembly post that could compromise their IP65 moisture and dust rating of the signal. They may therefore allow a little water ingress in driving rain or where water can pool on the mounting pillar and be sucked in with differential temperature changes.

Westinghouse are currently working to identify the serial numbers of signals with *at risk* covers. They will contact each affected customer as soon as they have this available. They recommend that all signals with *at risk* covers be returned to Westinghouse where they will fit a new cover at no cost.

In the meantime, they recommend that you inspect any signals due for installation and do not install any with *at risk* covers. Any signals installed in 2006 should be inspected during the next routine maintenance visit.
