Asbestos Risk for Signalling Personnel – UM71 Track Circuits

ESI-07-08

ARTC Network Wide

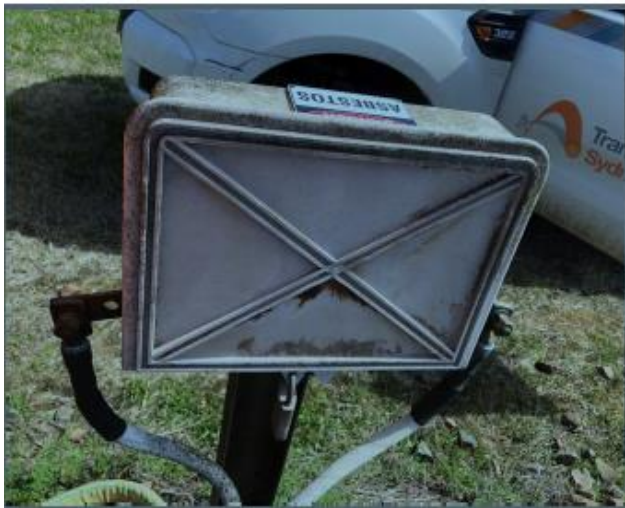
UM71 (CSEE) track circuit SI units with serial numbers before AB19782, manufactured prior to September 1987, are confirmed by the manufacturer to have been used in an inter-winding spacer material that contains asbestos. The inter-winding spacer material is fully enclosed within the tape bandage that also encloses the SI unit winding. They can be identified by the distinct X on the lid (as per Figure 1 below).

Figure 1: External view of UM71(CSEE) SI Unit

Inspect RX and TX trackside units (without removing covers) for UM71 to identify if it has the distinct X on the front covers as per Figure 1 above. If yes, please affix the Asbestos identification marker to the trackside units.

Do not open the lid to check the manufacturing date.

Signal maintenance personnel are advised NOT to remove the lids of the identified SI Units for the purpose of maintenance inspections, cleaning, or fault-finding activities.

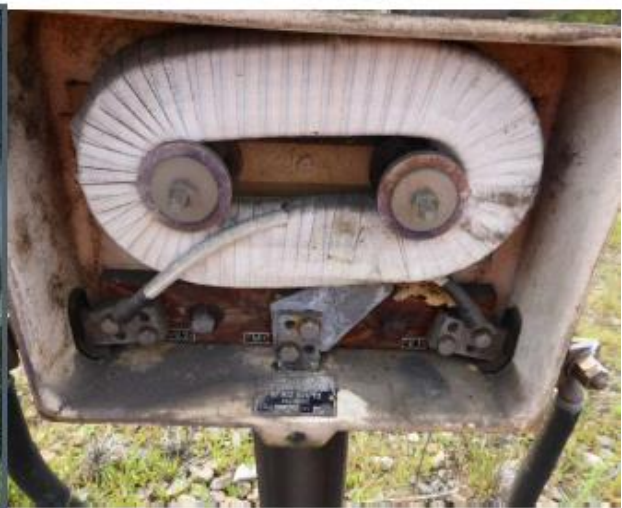
Figure 2: Internal view of UM71(CSEE) SI Unit

If the taping which encloses the winding is not damaged or removed, SI units do not pose a hazard in normal use. However, due to the age of the SI units and possible degradation of protecting material, additional precautions are to be taken to eliminate any possibility of exposure to the maintenance personnel as mentioned further in this document.
