Store 74 Battery Charger Resonating Capacitors

ESI-09-01

ARTC Network Wide
SMS

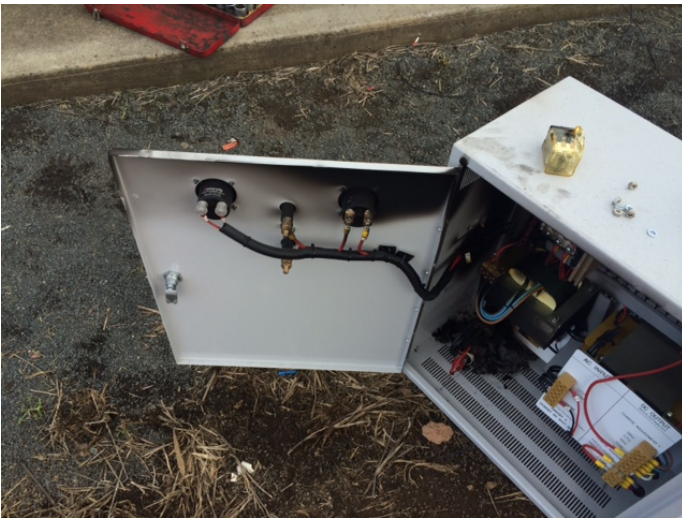
Smoke was observed coming from a Store 74 Battery Charger during a past failure. The Battery Charger door was opened and a fire started in the charger. The fault, smoke and fire were the result of a failed resonating capacitor in the Store 74 Battery Charger.

Figure 1: Capacitor failure and fire in Store 74 battery charger.

1. Open the Store 74 Battery Charger and visually examine the resonating capacitors.
2. If either capacitor shows signs of being affected by heat or other damage, this is to be reported to the signal engineer. The supplier Exelectronics is to be contacted for replacement capacitors.

3. The replacement capacitors are to be fitted and the Store 74 Battery Charger tested for correct operation.

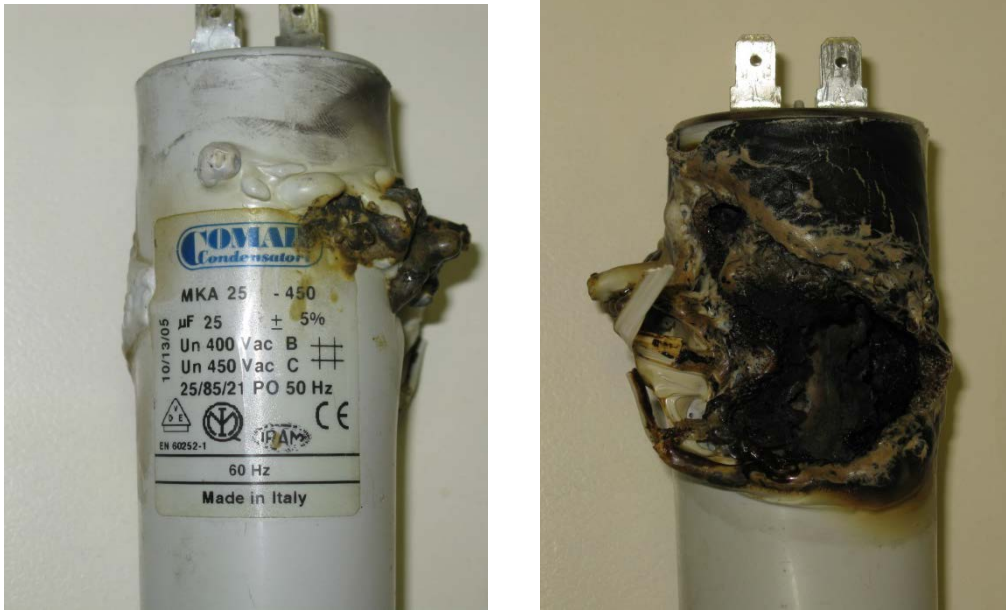
The original capacitors are no longer available and substitute capacitors have caused problems and failed.

Figure 2: Failed resonating capacitor. Front and back.
