# Cracks in 53kg/m Switches

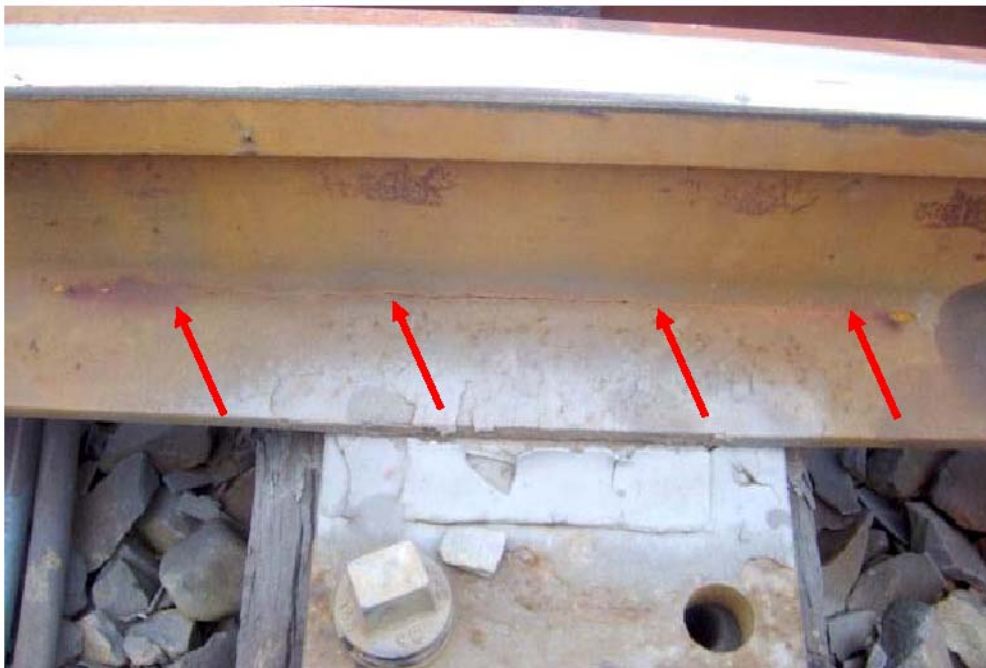
Cracks have been found in 53kg/m switches running along the switch between the foot and web of the rail. The crack should be easily visible and there may also be rust marks.

Patrol staff are to check 53kg/m switches for any similar cracking during their regular inspections. Even after checking once, patrollers should continue to be vigilant for this problem.

Staff involved in other inspections at turnouts should also be on the lookout for cracking running along the switches in the foot area.

Any defects should be dealt with in accordance with current standards. Details should also be reported to the Delivery Manager.
