Urgent Review of K Crossings on Diamonds

Issued by	Date
John Cowie, Manager Standards	08 May 2007

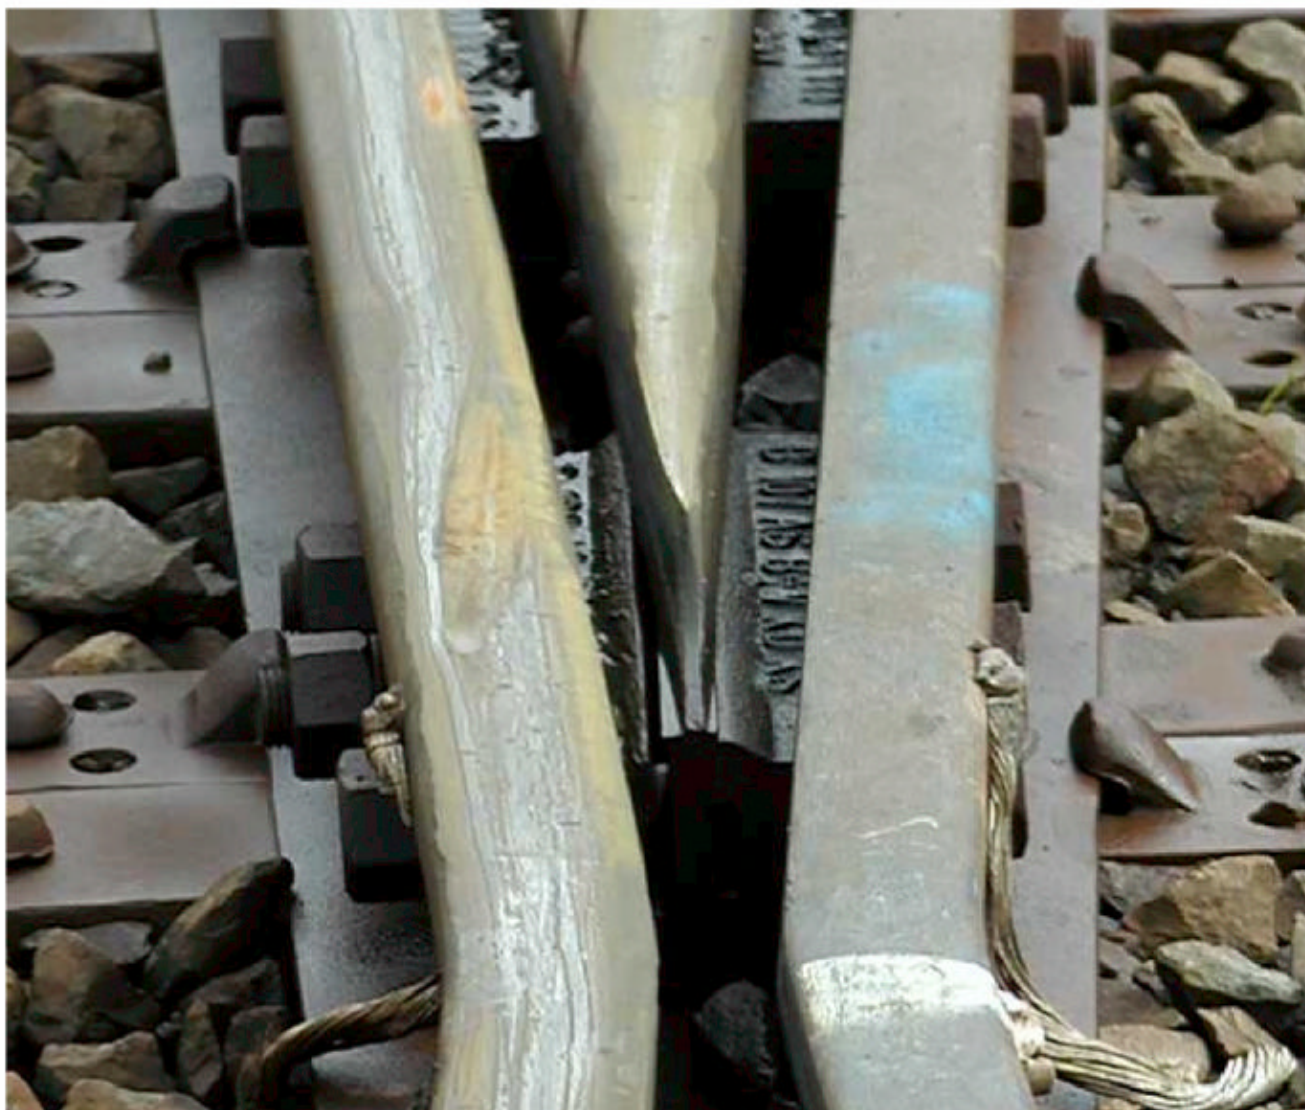
A typical K Crossing nose in Category 3 is shown in Figure 1. The ramp up to the nose is worn and rolled over.

Figure 1 A typical K Crossing nose in Category 3. The ramp up to the nose is worn and rolled over.

- If the wear is already in category 3 or 4 (from Table 1) replacement or upgrading will still be required and increased monitoring should be arranged.
- In addition if wear is in category 4 (from Table 1) then the speed of trains should be reduced until the crossing can be replaced or upgraded.
