Urgent Review of K Crossings on Diamonds

Applicability

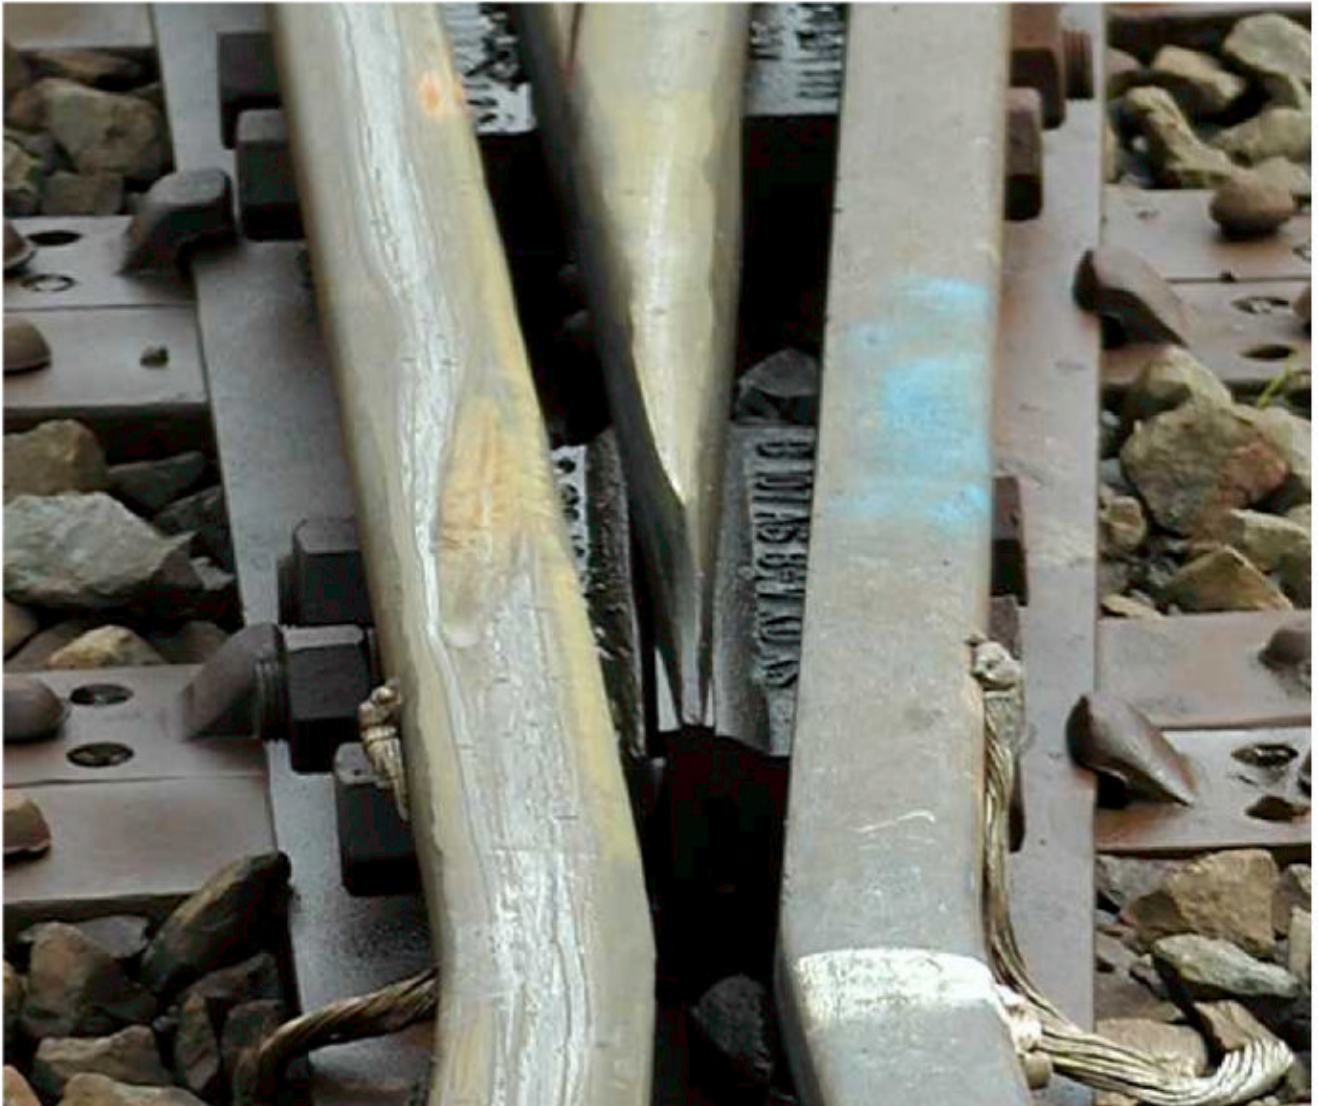
A typical K Crossing nose in Category 3 is shown in Figure 1. The ramp up to the nose is worn and rolled over.

Figure 1 A typical K Crossing nose in Category 3. The ramp up to the nose is worn and rolled over.

- If the wear is already in category 3 or 4 (from Table 1) replacement or upgrading will still be required and increased monitoring should be arranged.
- In addition if wear is in category 4 (from Table 1) then the speed of trains should be reduced until the crossing can be replaced or upgraded.

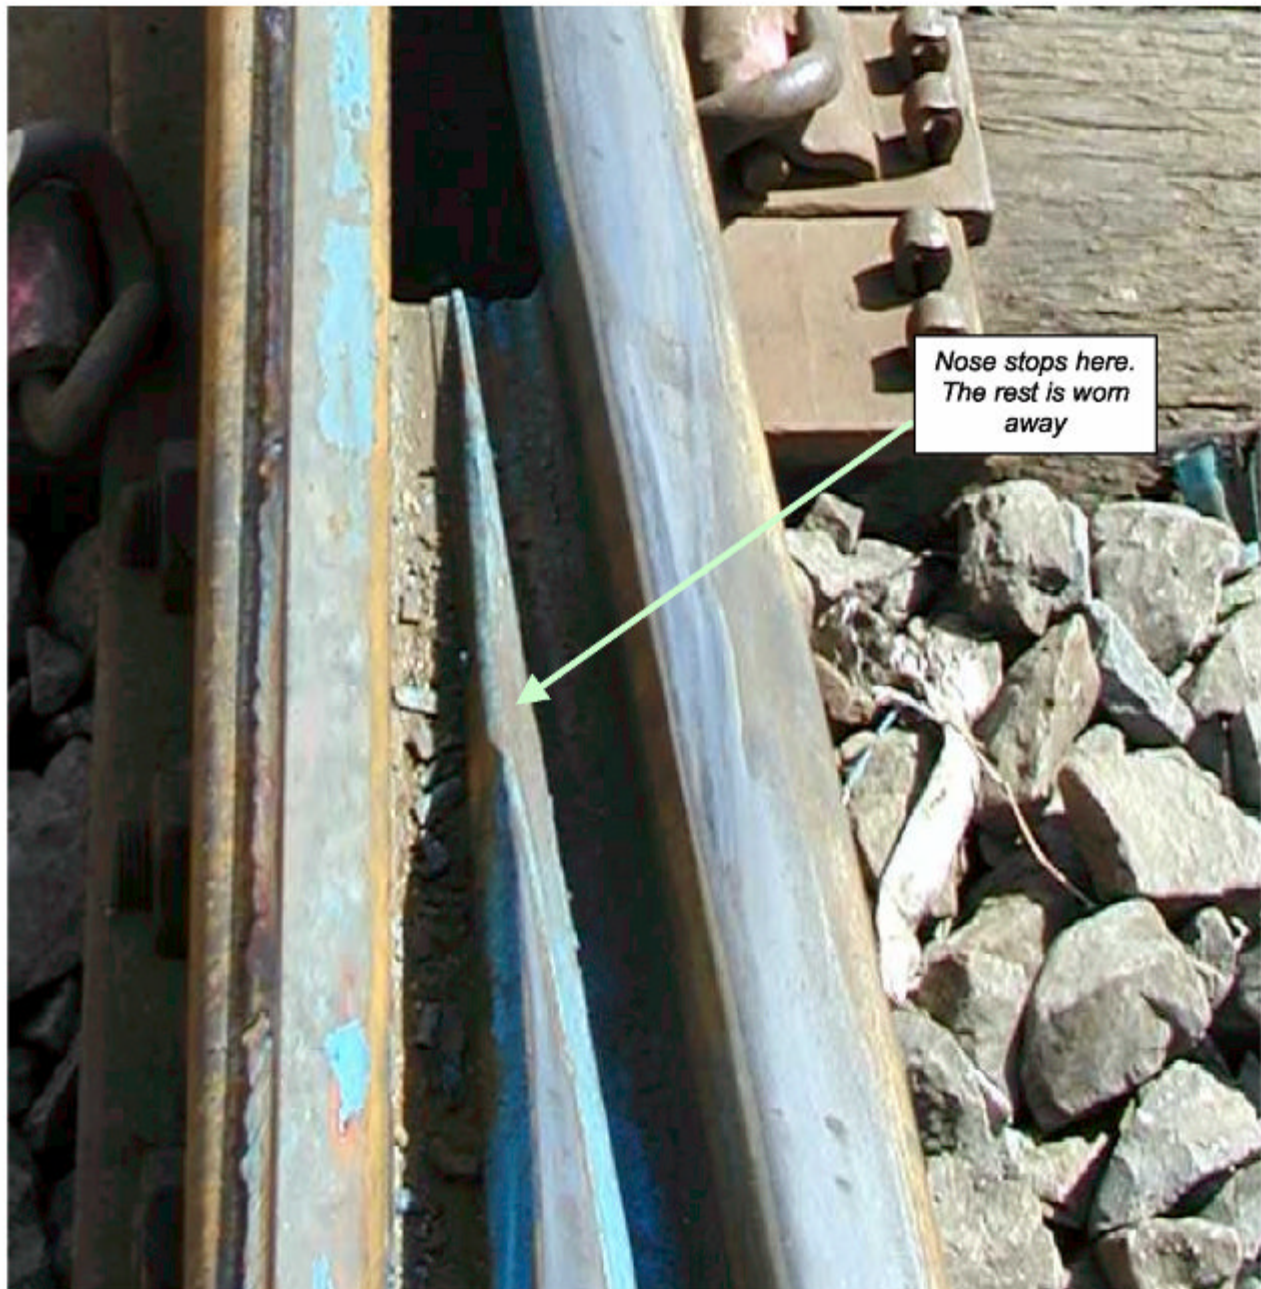
An example of K Crossing nose in Category 4 is shown in Figure 2. The nose and ramp has been completely worn away.

Figure 2. The ramp and nose of the K Crossing have been completely worn away. Note that the wingrail on the LHS has been raised to reestablish checking for the diamond.

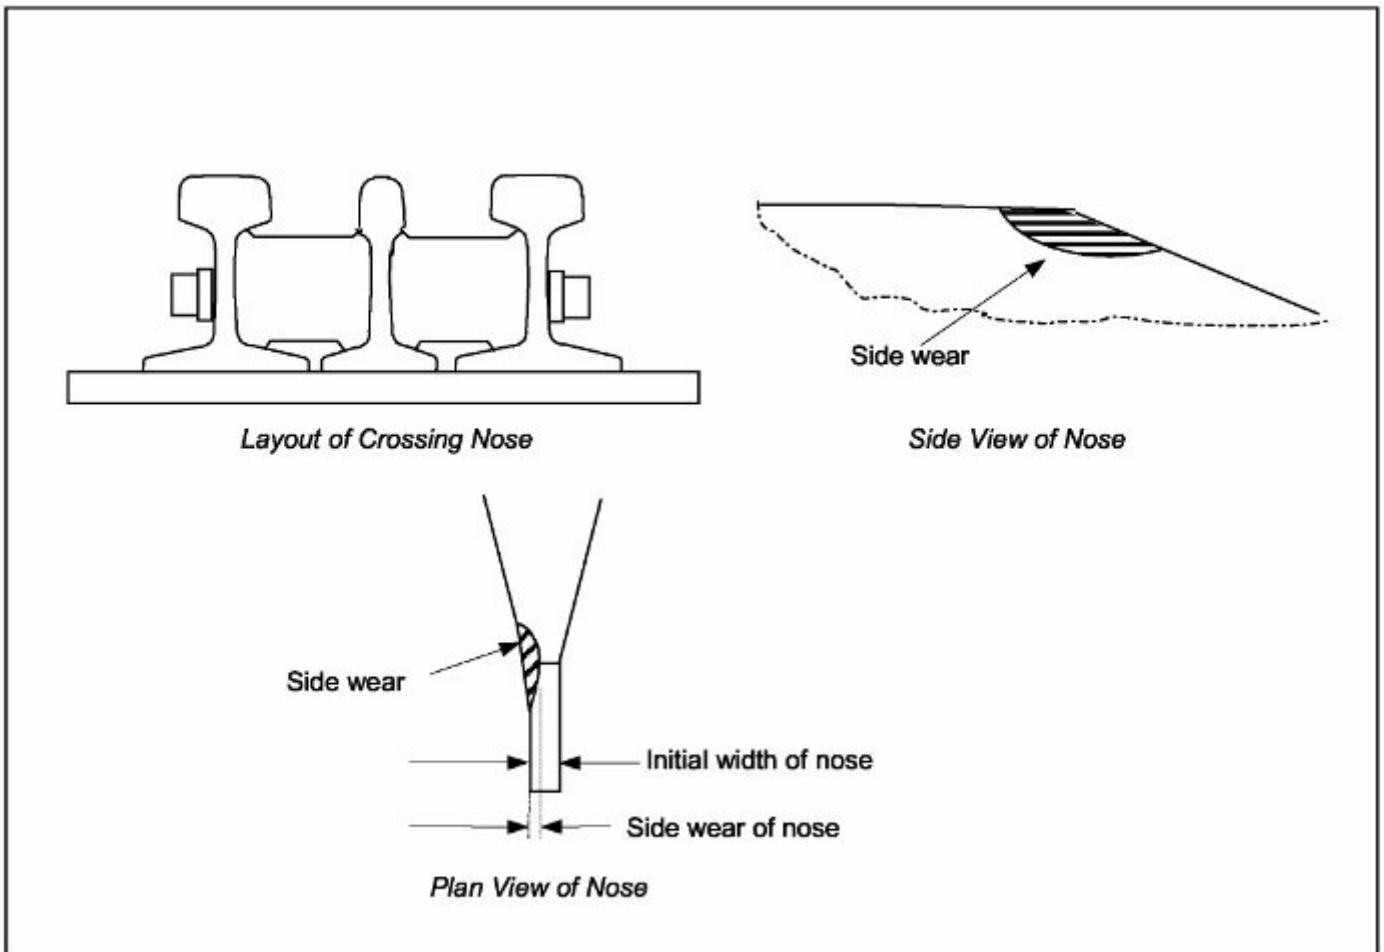
Figure 3

Measurement of wear and recommended response is given in Table 1 with details of wear shown in Figure 3.

Category	Condition	Response
1	Side wear on any one side of no more than 3mm and side wear on both sides totalling no more than 5 mm	Normal monitoring
2	Side wear of greater than 3mm on one side but with at least 2mm of the original width remaining* or side wear on both sides totalling more than 5mm but with at least 2mm of the original width remaining*	Arrange investigation and appropriate corrective action
3	Side wear where there is less than 2mm remaining of the original width	Urgent attention required and review permissible speed
4	Side wear where nose or ramp is completely worn away or broken away at any point Where there is any loss of height in the ramp up to the nose	Trains should not be permitted to pass excepting where certified by the nominated Delivery Managers or nominated representative and then only at greatly reduced speed.
