AUSTRALIAN RAIL TRACK CORPORATION LTD

Engineering Practices Manual Civil Engineering

Rail Defects Handbook

RC 2400

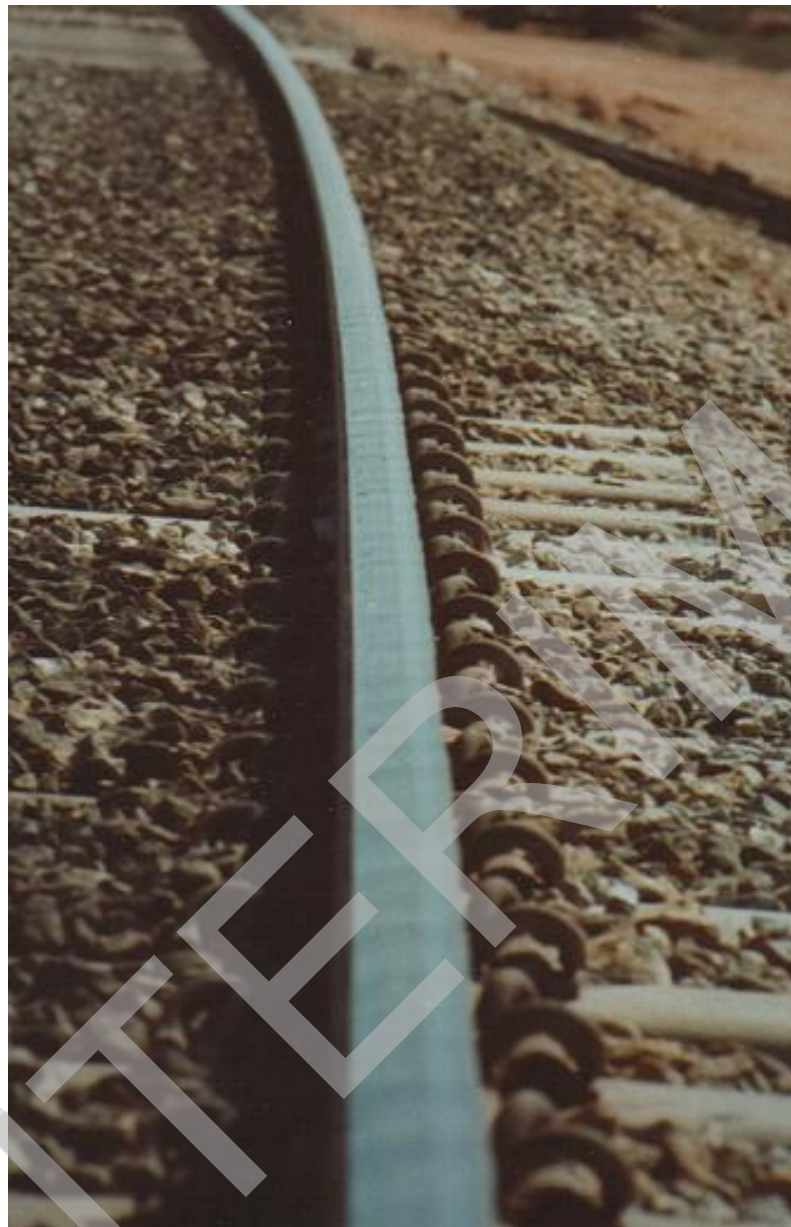
Figure 6 (a) Long pitch corrugations on the running surface

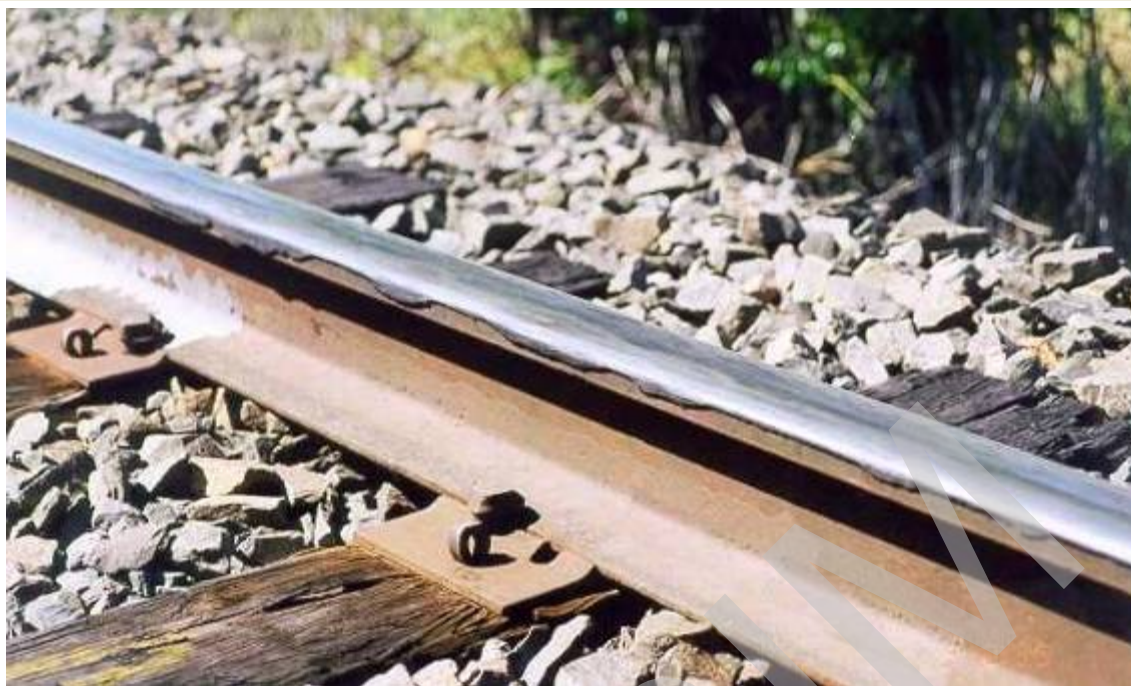
Figure 6 (c) Rail plastic flow associated with long pitch corrugations

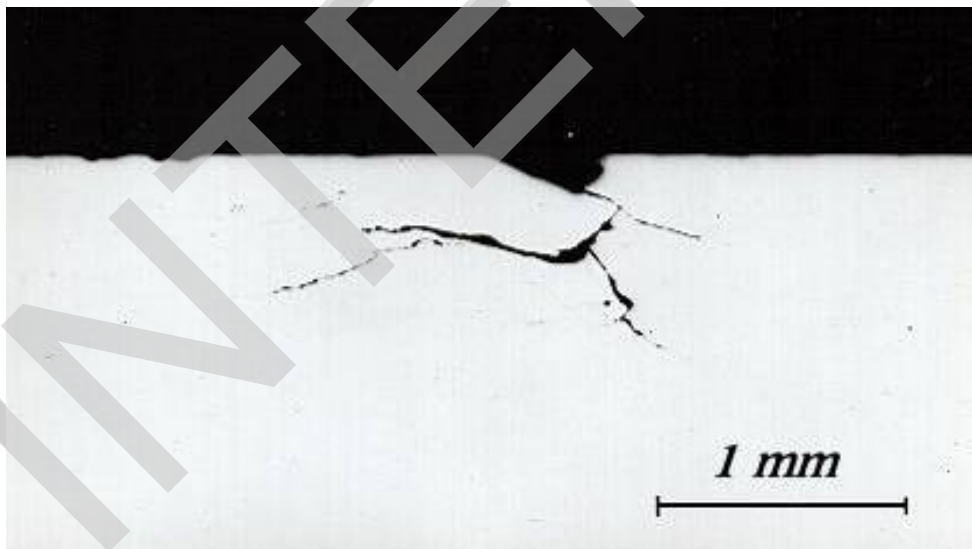
As illustrated in Figure 9, the cracks are initiated at or very close to the rail surface, typically occur at about 2-5 mm intervals along the rail, and can grow to 2-5 mm in depth, at a downward angle of about 10° - 30° to the rail surface, gradually spreading across the rail head. Once this occurs they usually break out as small “wedges or spalls”.

Figure 9 (a) Transverse section of a rail showing the initial stages of development of checking cracks and spalls

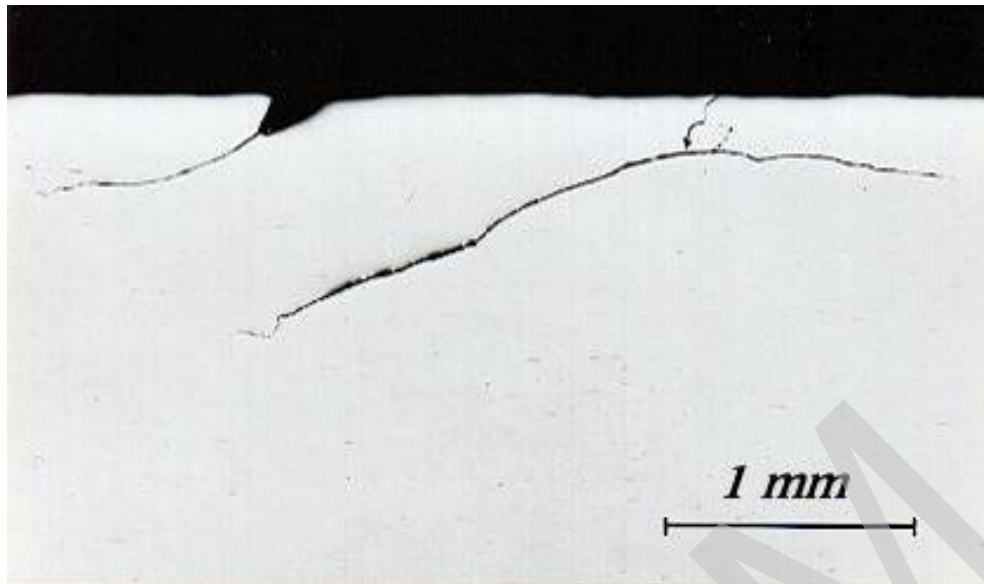
Figure 9 (b) Longitudinal section of a rail showing the initial stages of development of checking cracks and spalls. Note how the crack initially grows into the rail head but then levels out.

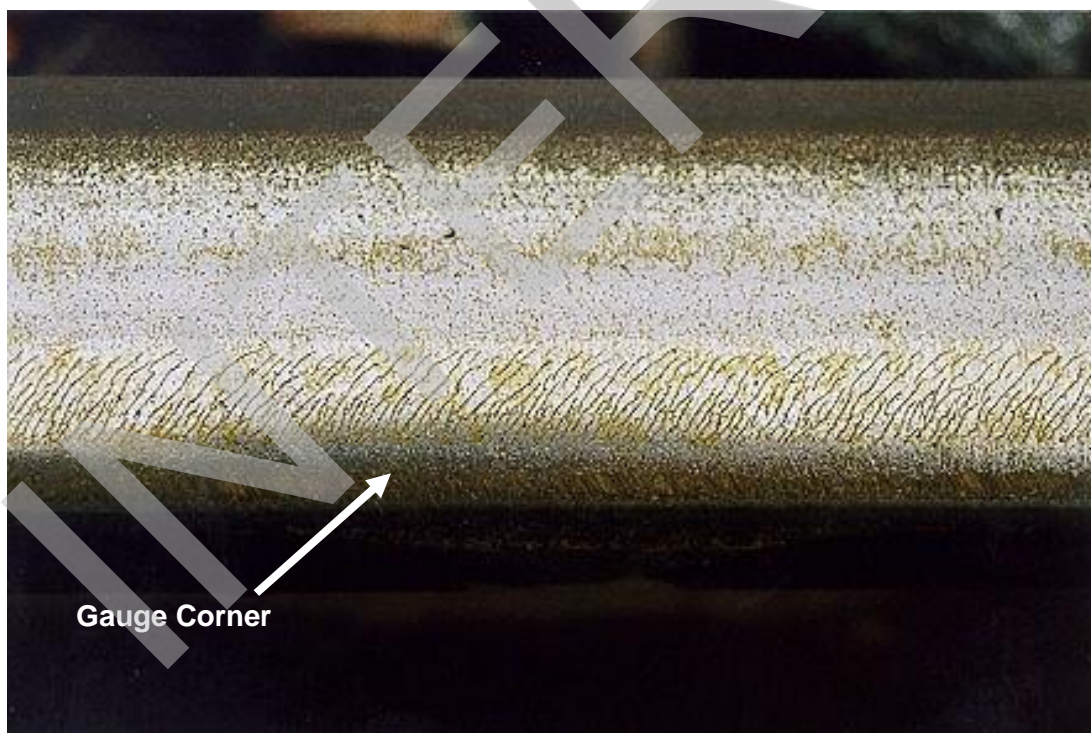
Figure 10 (a) Initial stage of development of gauge corner checking cracks

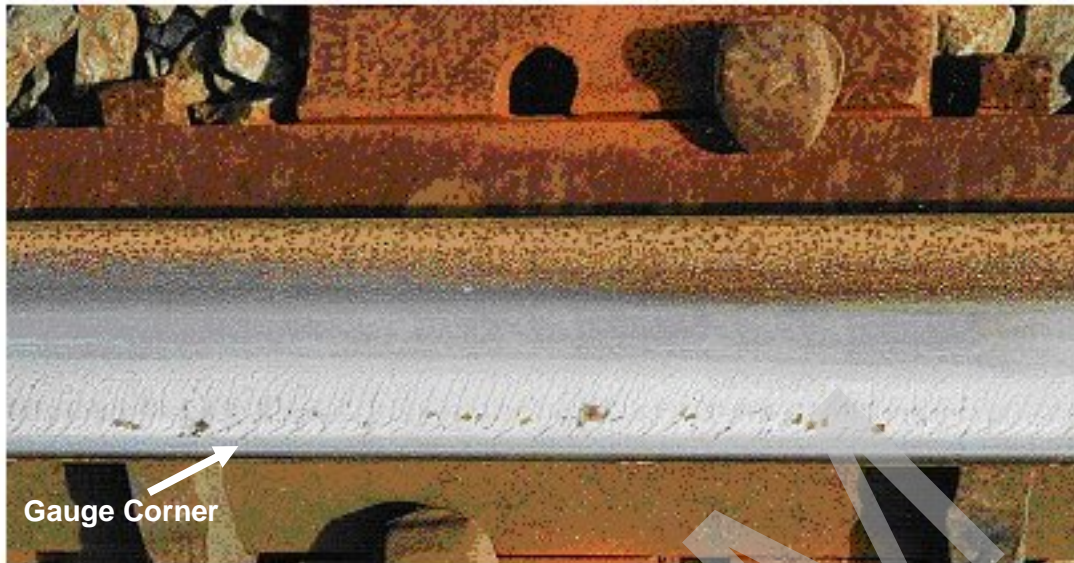
Figure 10 (b) Intermediate stage of development of gauge corner checking cracks and spalls

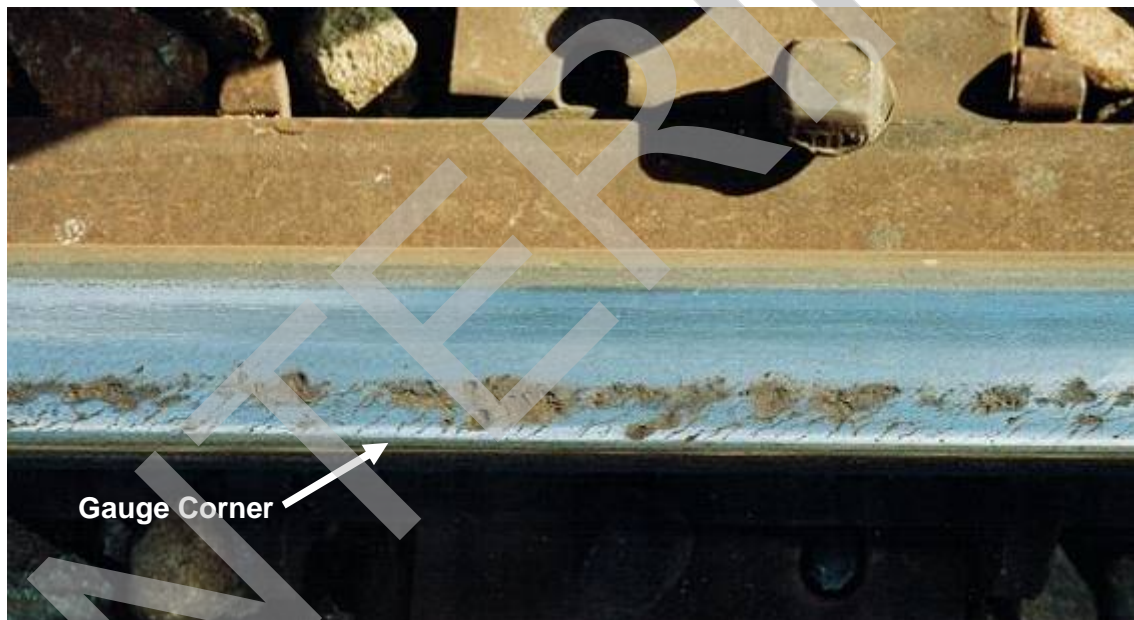
Figure 10 (c) Severe stage of development of gauge corner checking cracks and spalls

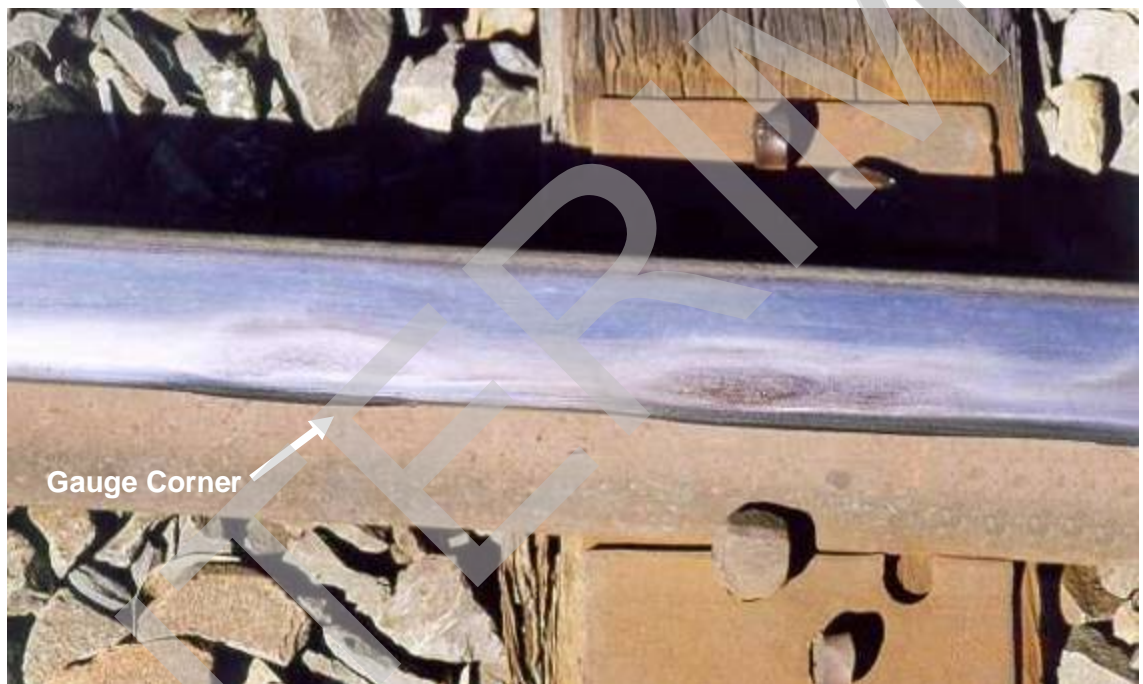
In the initial stages of development, shelling defects become noticeable as dark spots in the gauge corner region of the rails.

Figure 11 (a) Initial stage of shell development (dark spots)

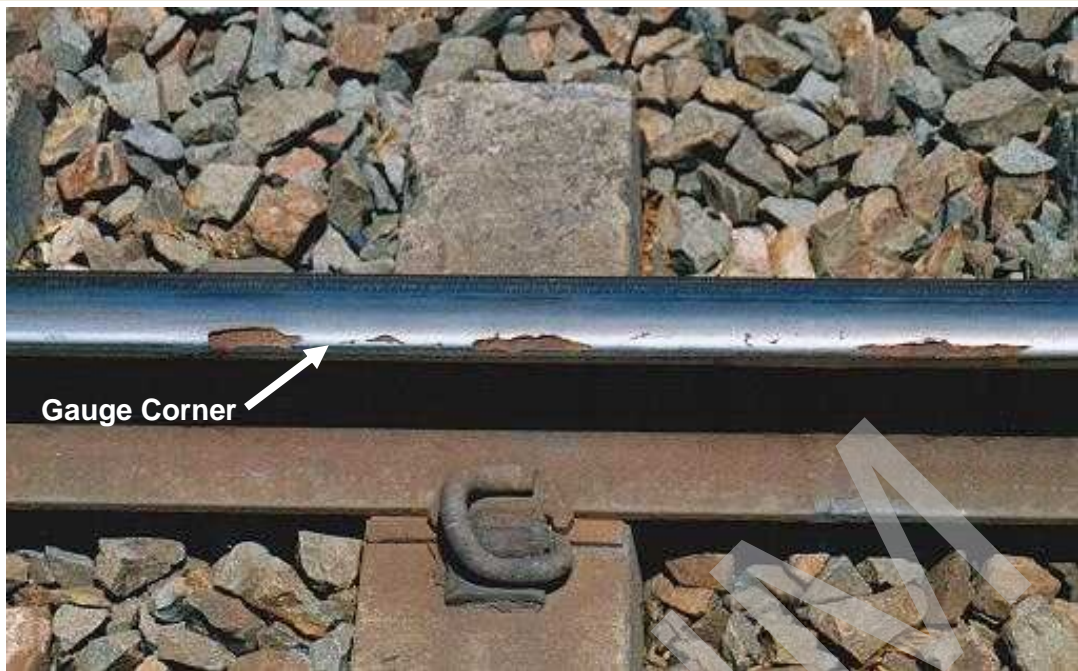
Figure 11 (b) Intermediate stage of shell development

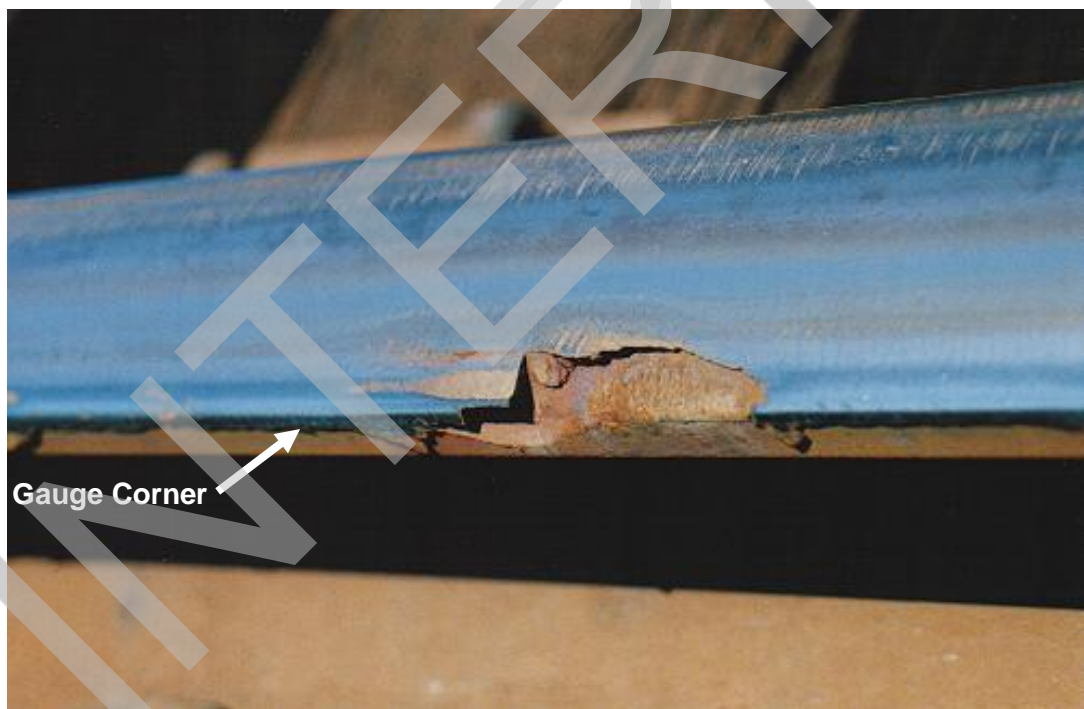
Figure 11 (c) Severe stage of shell development

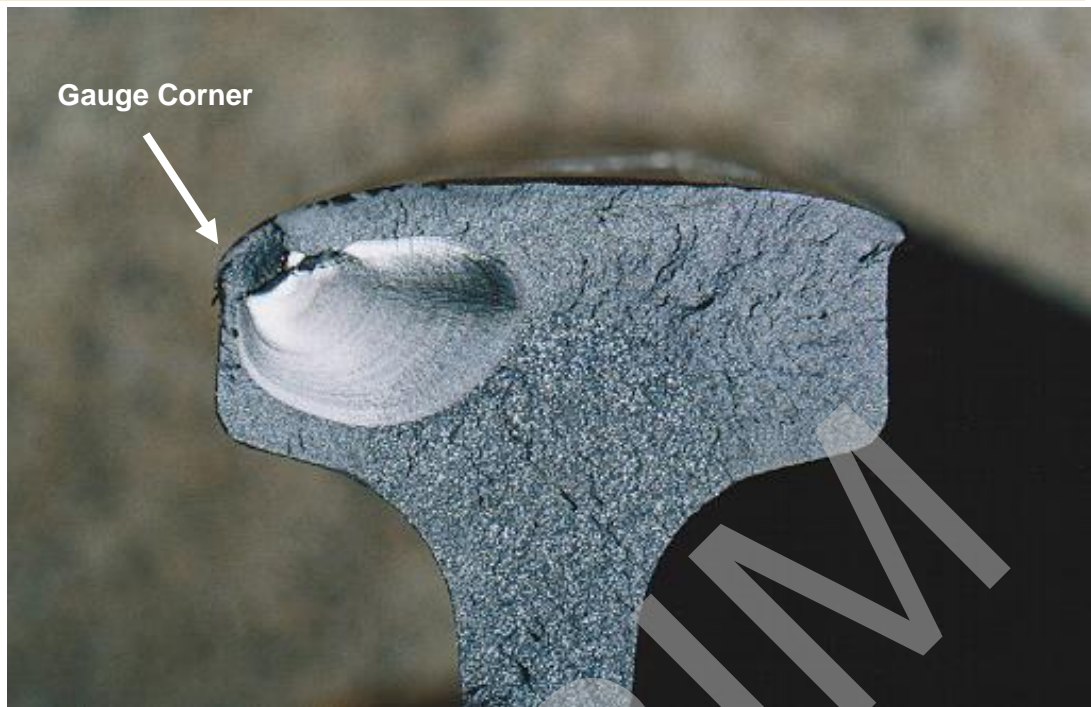
Because of their internal nature, transverse defects cannot be visually detected, and hence must rely on regular ultrasonic rail inspection.

Figure 12 Small Transverse defect in the rail head initiated from shelling

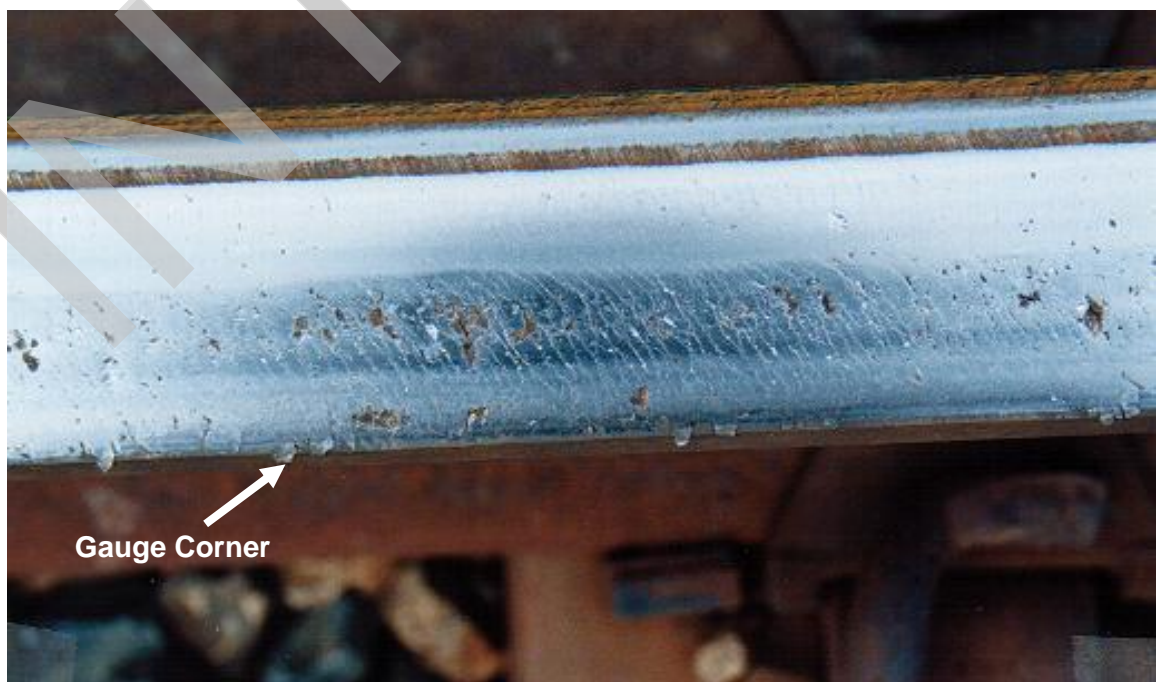
Figure 13 Flaking or running surface checking defects with minor spalling

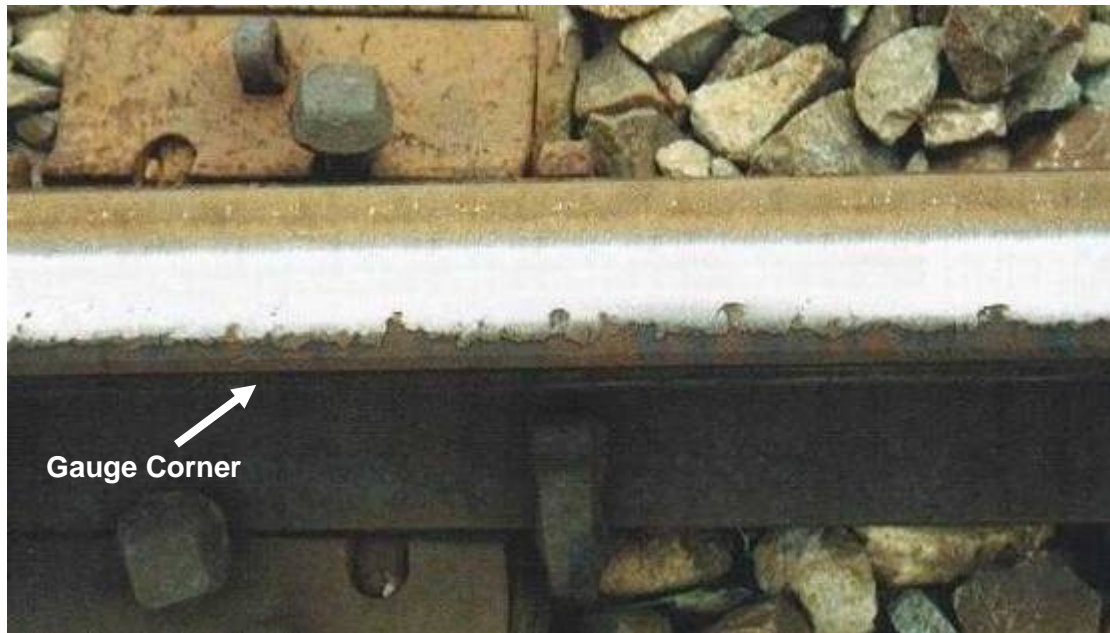
The establishment of a considerable gauge corner undercut also increases markedly the wear rate in the wheels and rails, and enhances the contamination of the gauge corner and running surface by the lubricant.

Figure 18 Example of plastic flow in the high rail with excessive gauge corner relief

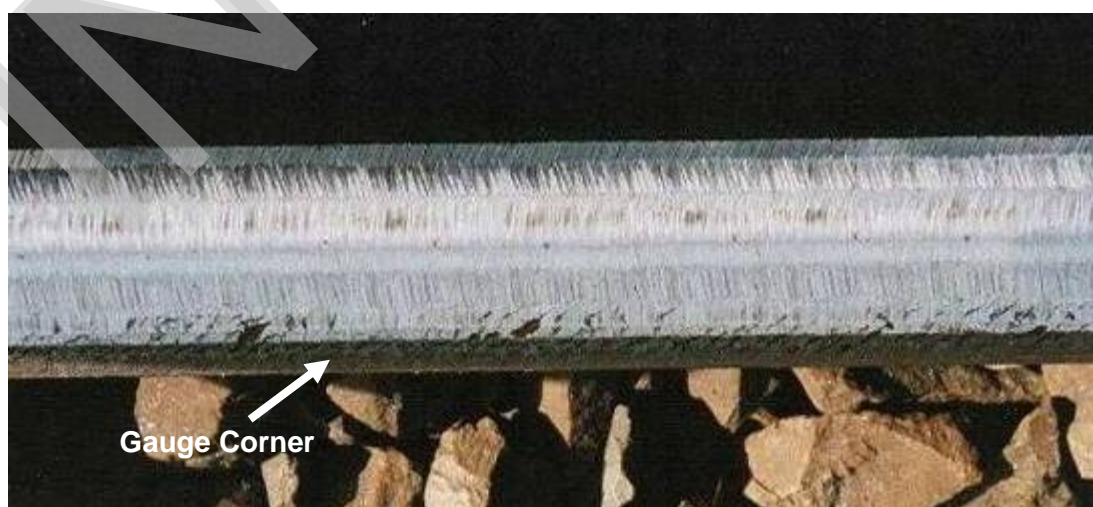
Figure 20 Examples of rail defects left in the gauge corner region of the rails after grinding

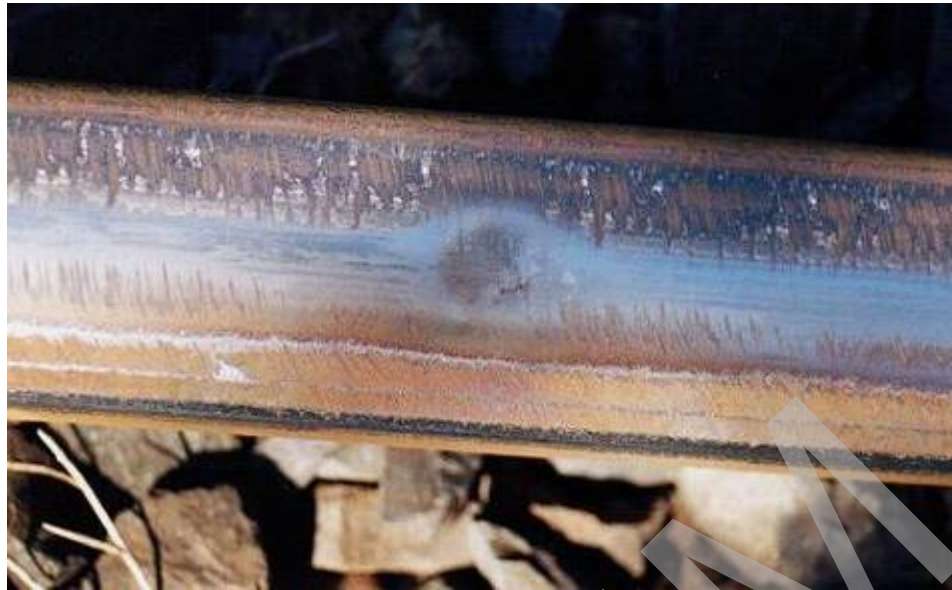
Figure 23(a) Examples of Rail Crown Squats - Small

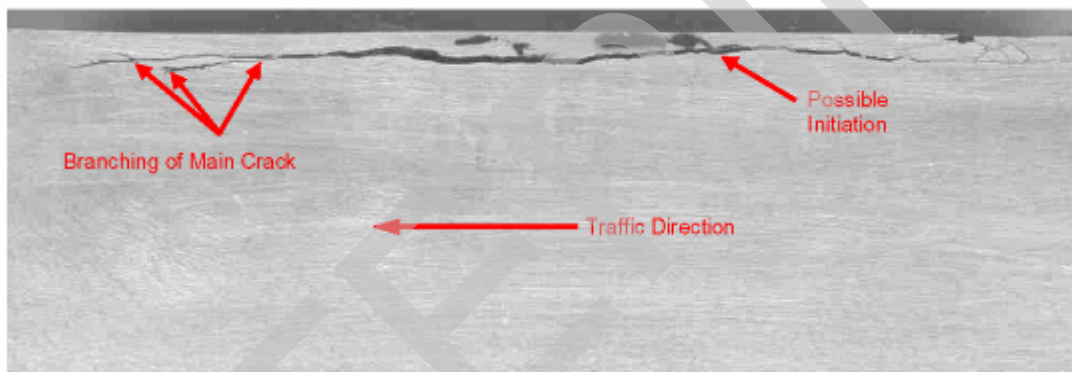
Figure 24 Sub-surface cracking associated with squat defect

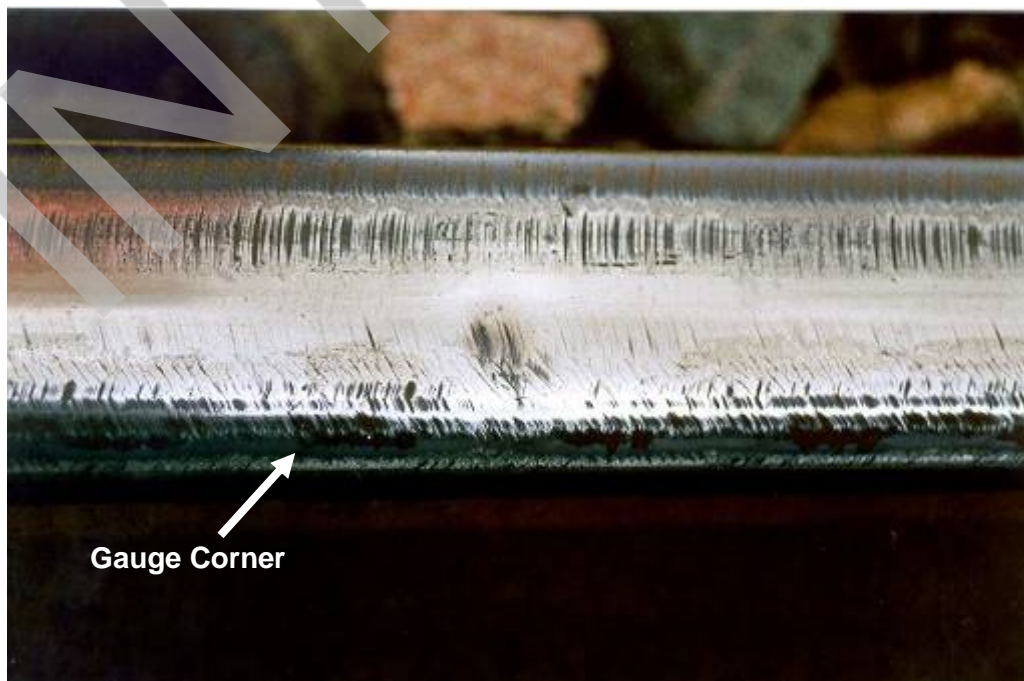
Figure 25(a) Examples of Gauge Corner Checking Initiated Squats - Small

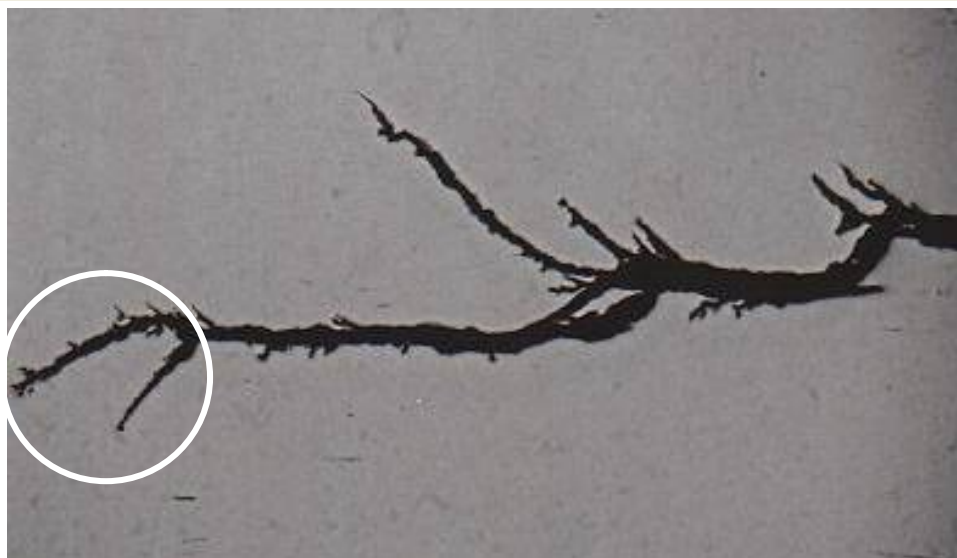
- There is a danger that the secondary or minor sub-surface cracks (illustrated in Figure 30) may turn down and grow on a transverse plane similarly to transverse defects, with the possibility of resulting in a complete rail failure if not detected in time.
- The depression on the running surface associated particularly with large squats (refer to Figure 23(c)) also increases the vertical impact wheel loadings applied to the rails, and consequently exacerbates the deterioration of both track and some vehicle components, in a similar way to dipped welds, rail corrugations and rail joints.
- The rail life is decreased, through the need for aggressive and expensive defect grinding.
- The possible shielding of ultrasonic signals from deeper defects during normal ultrasonic inspections.

*Figure 30 Sub-surface cracking associated with squats
(Longitudinal Section, rail contact surface is at the top of the photographs, x 50)*

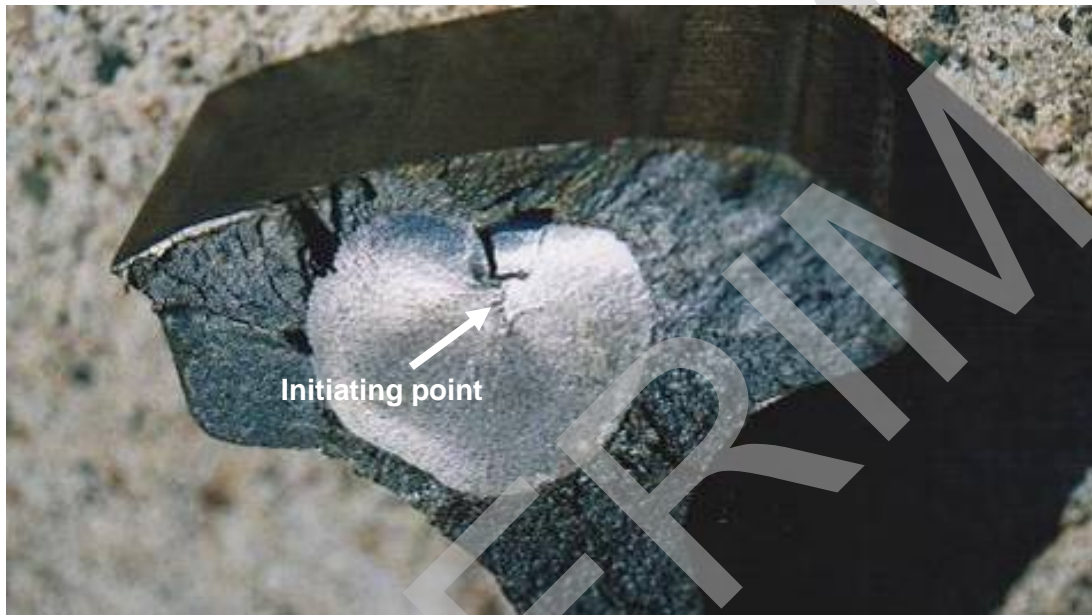
Figure 32(a) Example of Tache Ovale defects

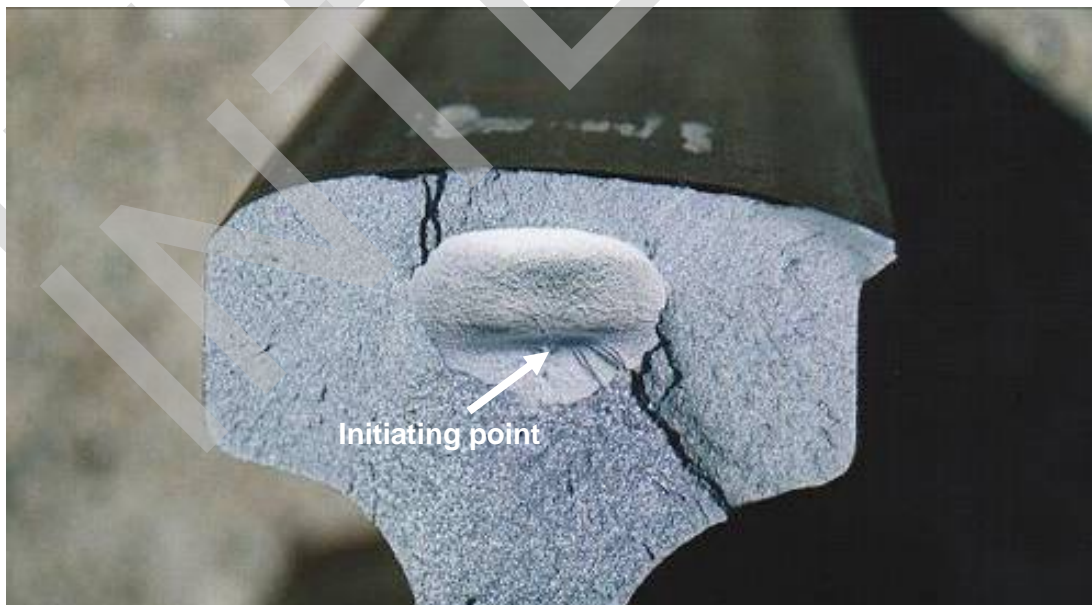
Figure 32(b) Example of Tache Ovale Defect

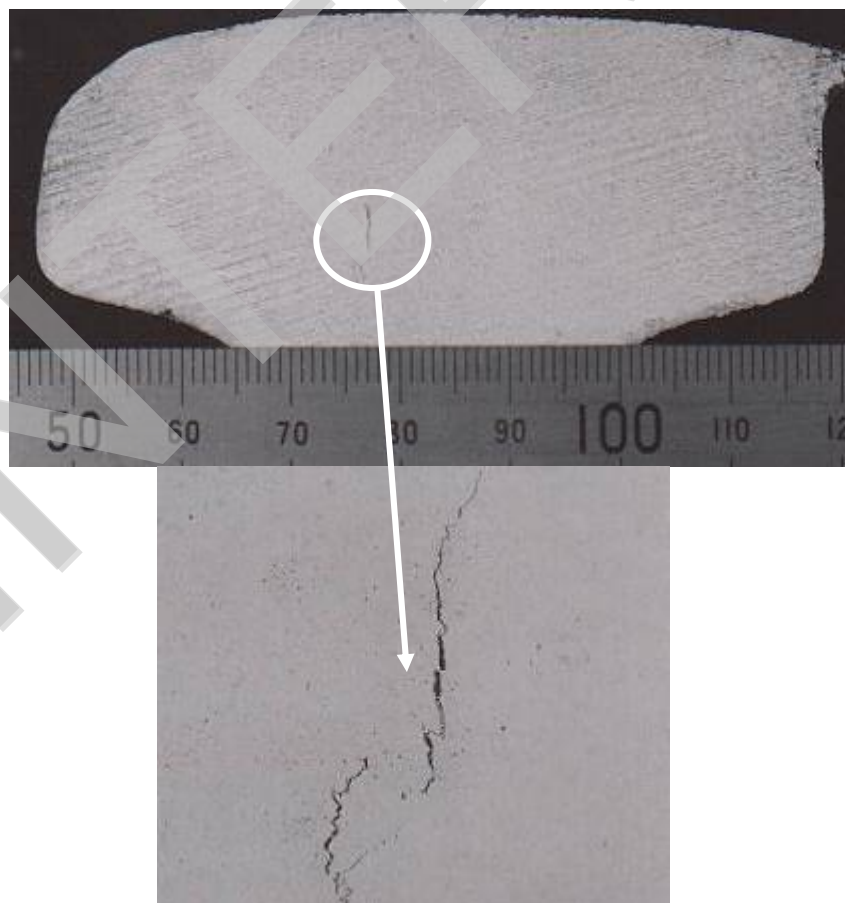
Figure 33 (a) Initial Hydrogen Induced Shatter Crack

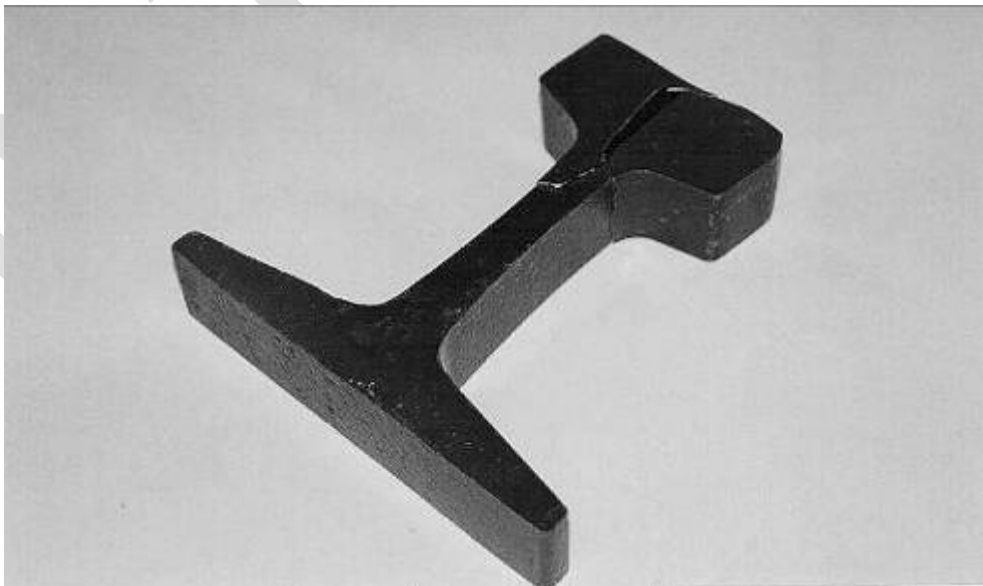
Figure 34 Vertical Split Head defect

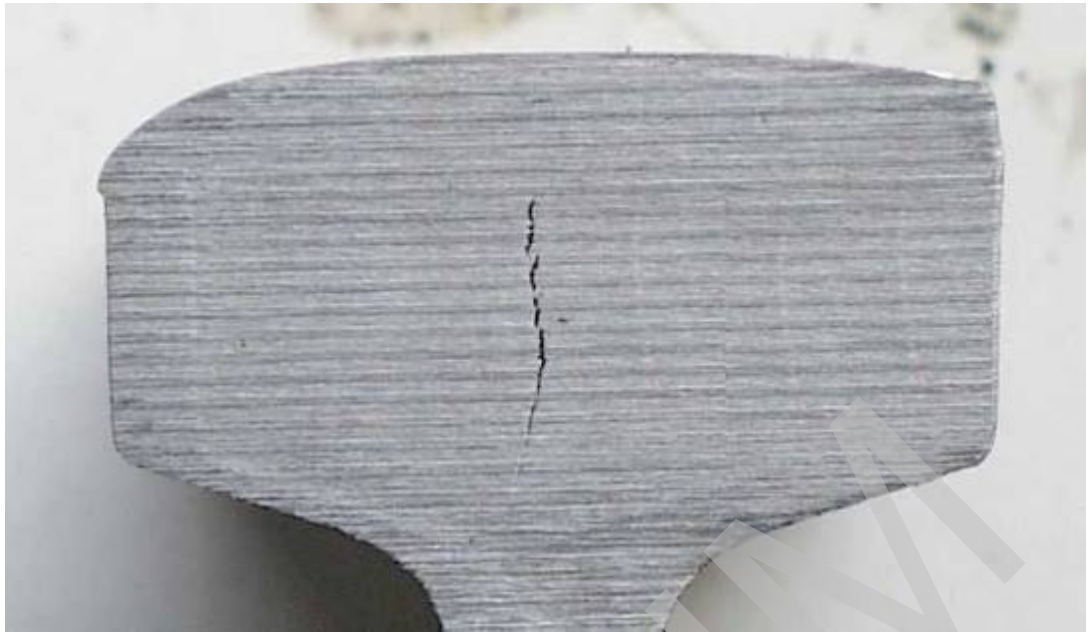
Figure 35(a) Medium Vertical Split Head defect

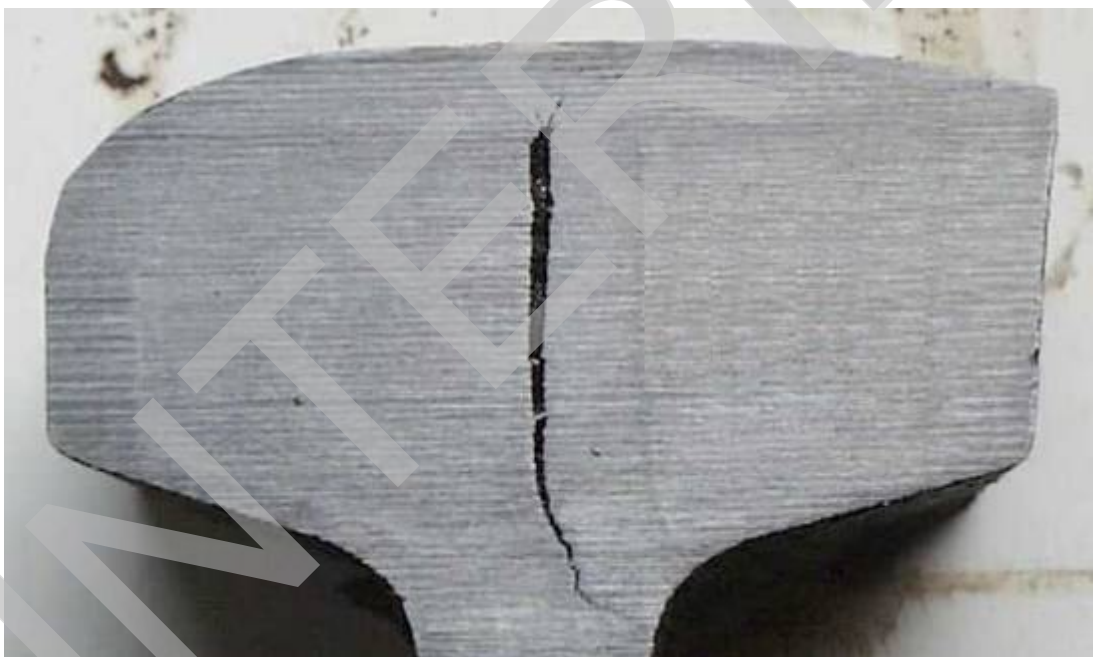
Figure 35(b) Large Vertical Split Head defects

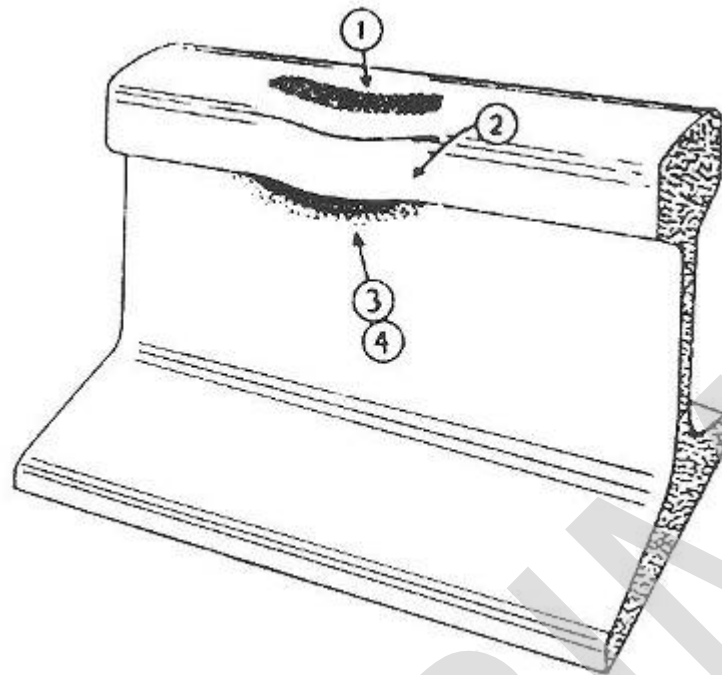
Figure 36(a) Visual indications of large vertical split head defects

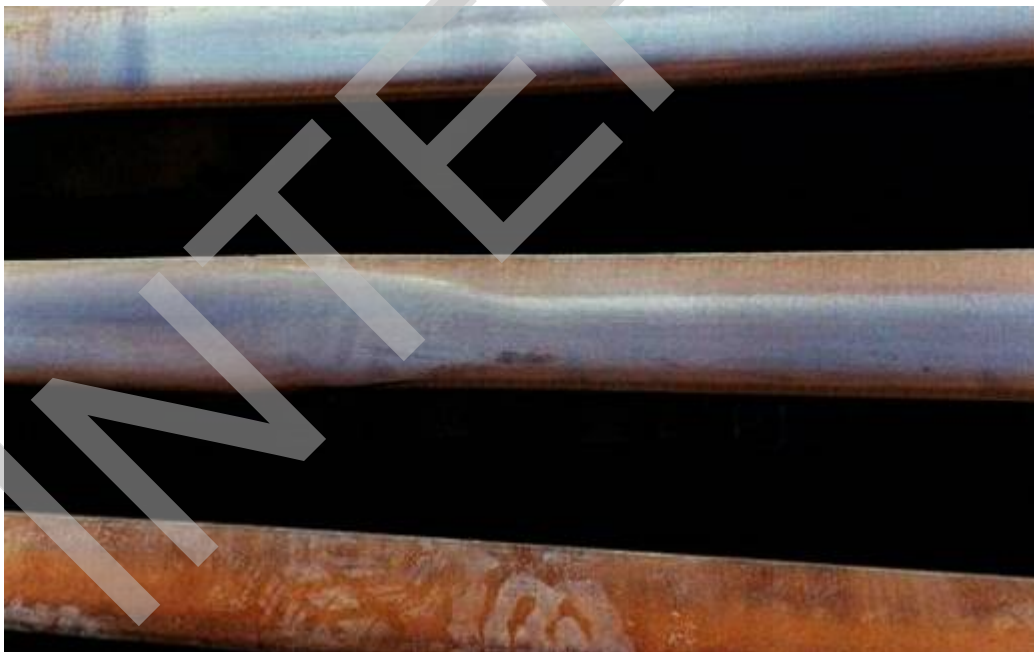
Figure 36(b) Widening of the wheel/rail contact band that occurs on top of the large vertical split head defects

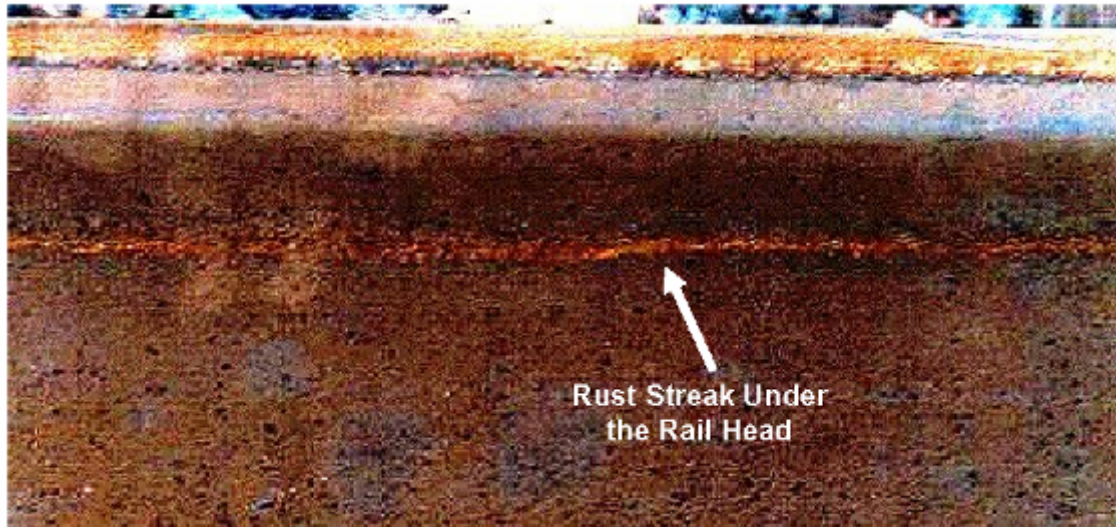
Figure 36 (c) Rust streak in the head/web transition associated with the breakout of the large vertical split head defects

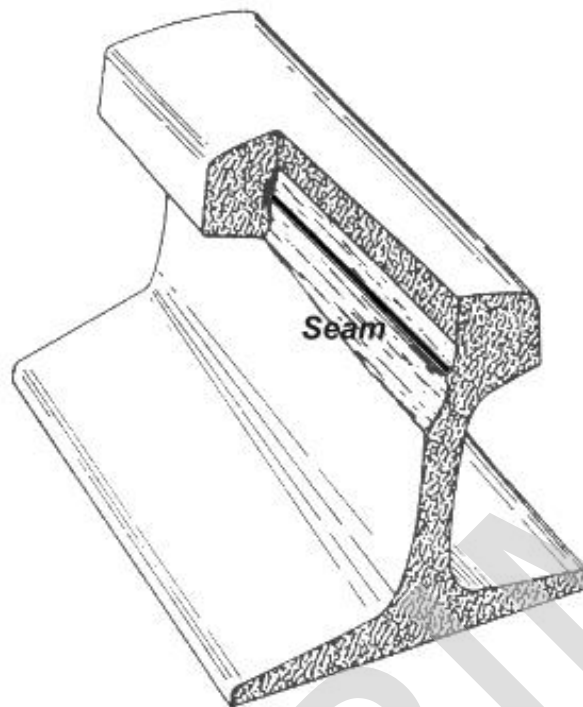
Figure 37 General appearance of Large Vertical Split Head defects

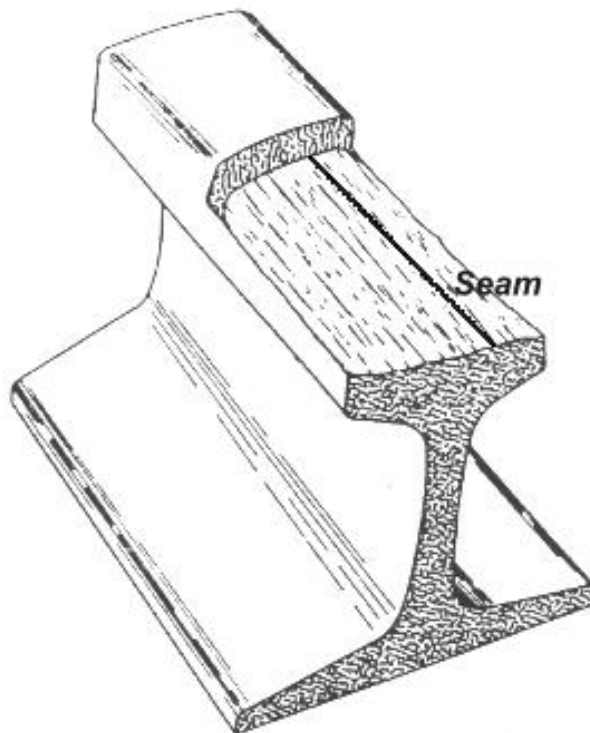
Figure 40 General appearance of large Horizontal Split Head defects

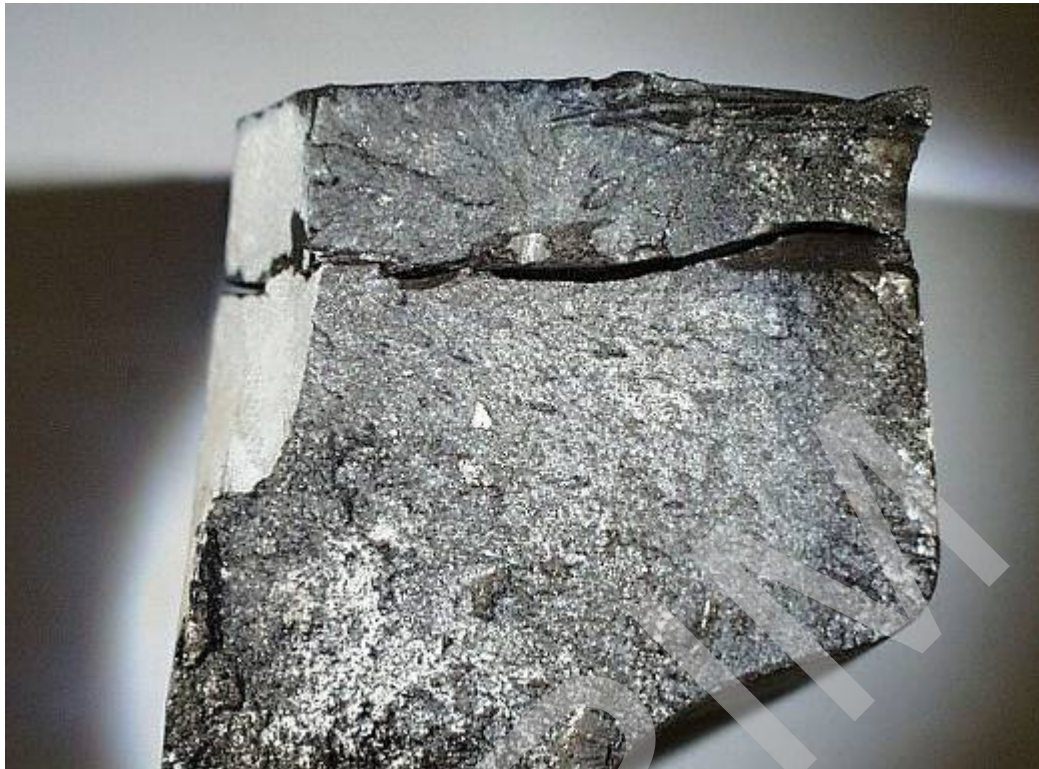
Figure 41 (a) Horizontal Split Head defect

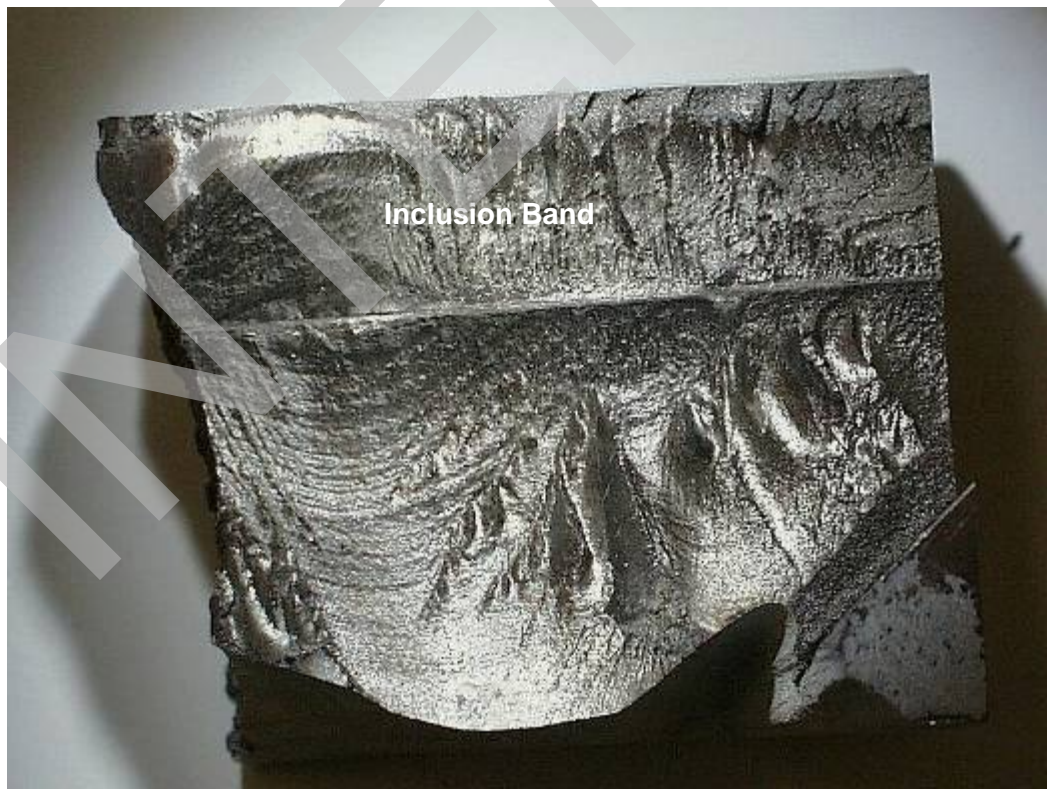
Figure 41 (b) Fracture surface of Horizontal Split Head defect

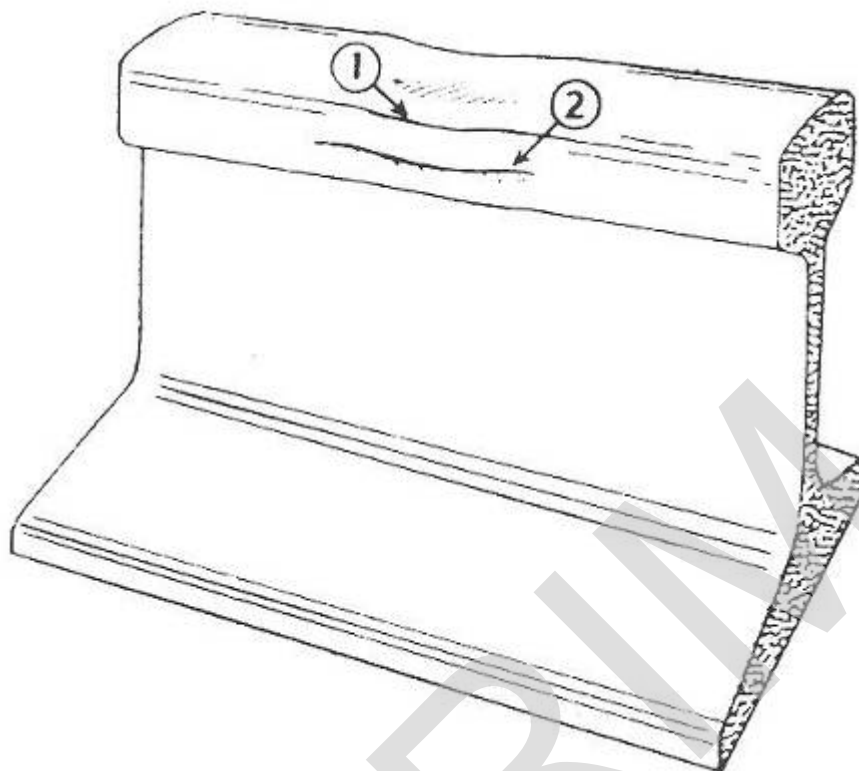
Figure 42 Visual indications of large Horizontal Split Head defects

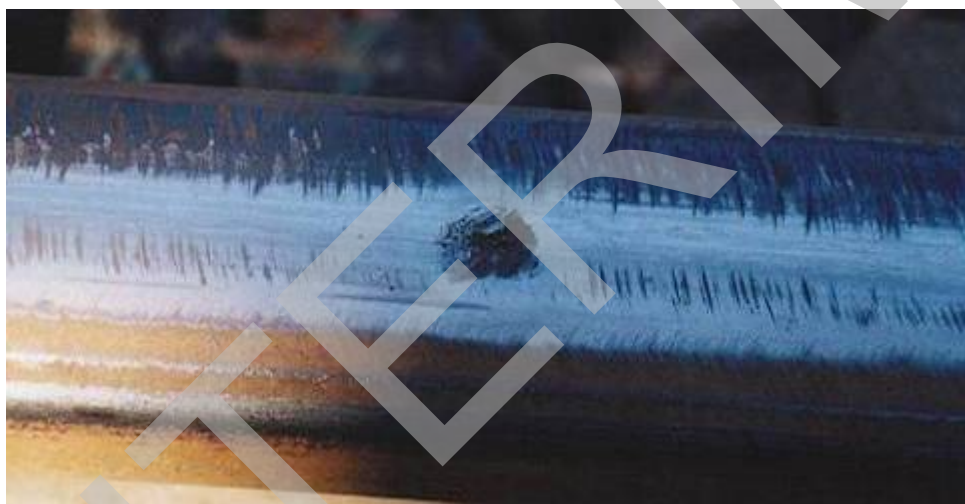
Figure 43(a) General appearance of Wheel Burns - Small
