AUSTRALIAN RAIL TRACK CORPORATION LTD

Engineering Practices Manual Civil Engineering

Rail Defects Handbook

RC 2400

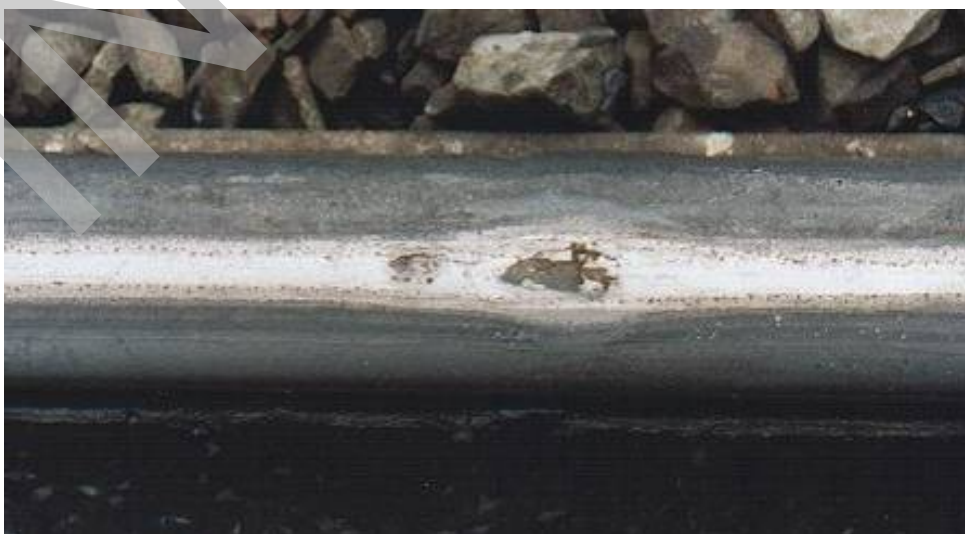
Figure 43(b) General appearance of Wheel Burns - Medium

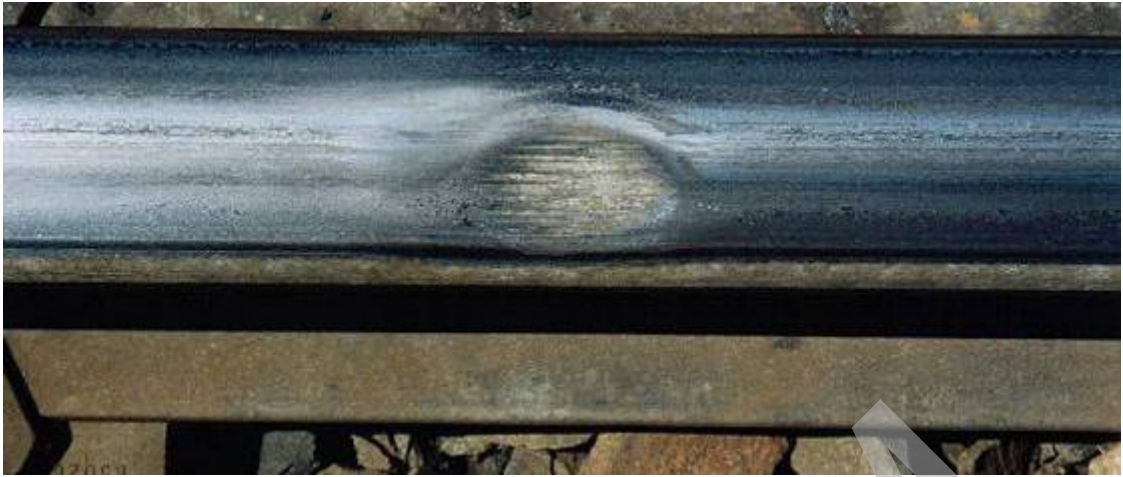
Figure 43(c) General appearance of Wheel Burns - Large

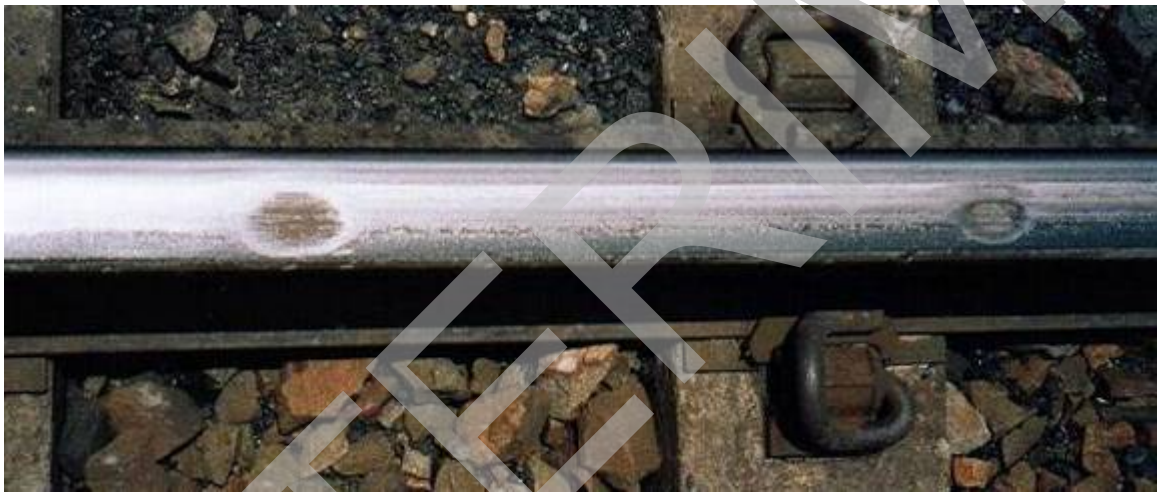
Figure 43(d) General appearance of Wheel Burns - Multiples

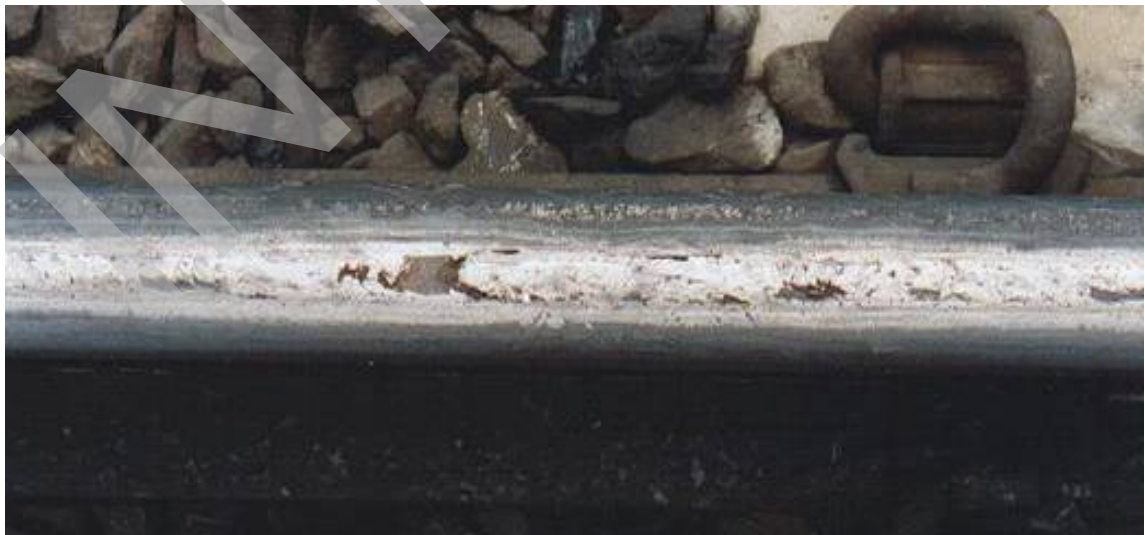
Figure 44 Wheel Burns produced by wheel slip on moving locomotives

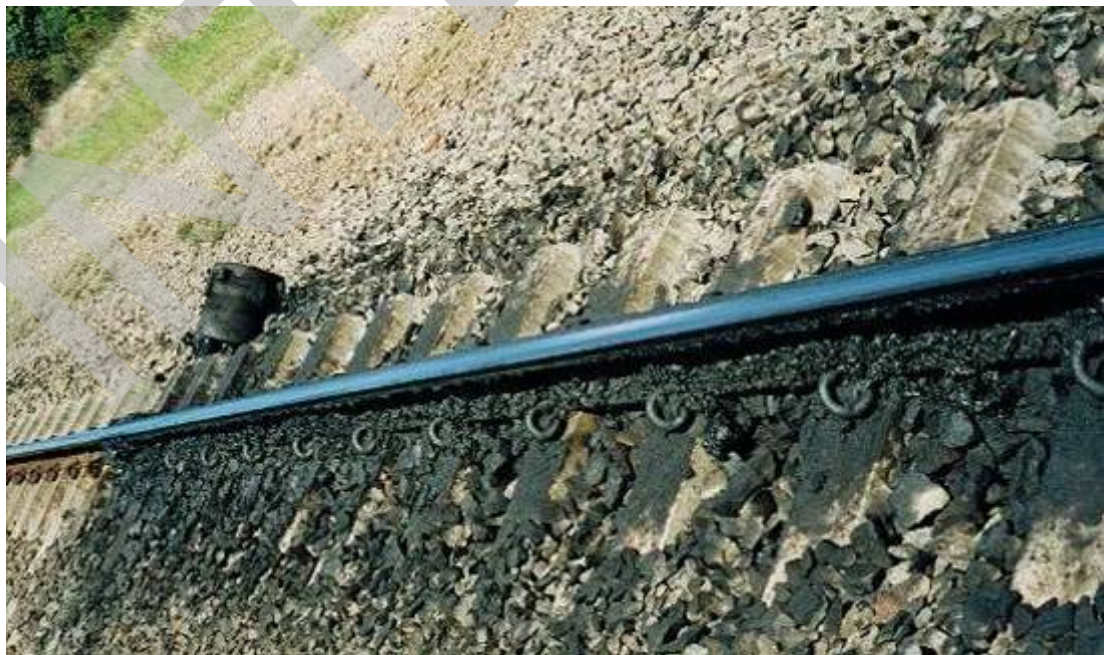
Figure 45 Running surface contamination of rails by lubricant

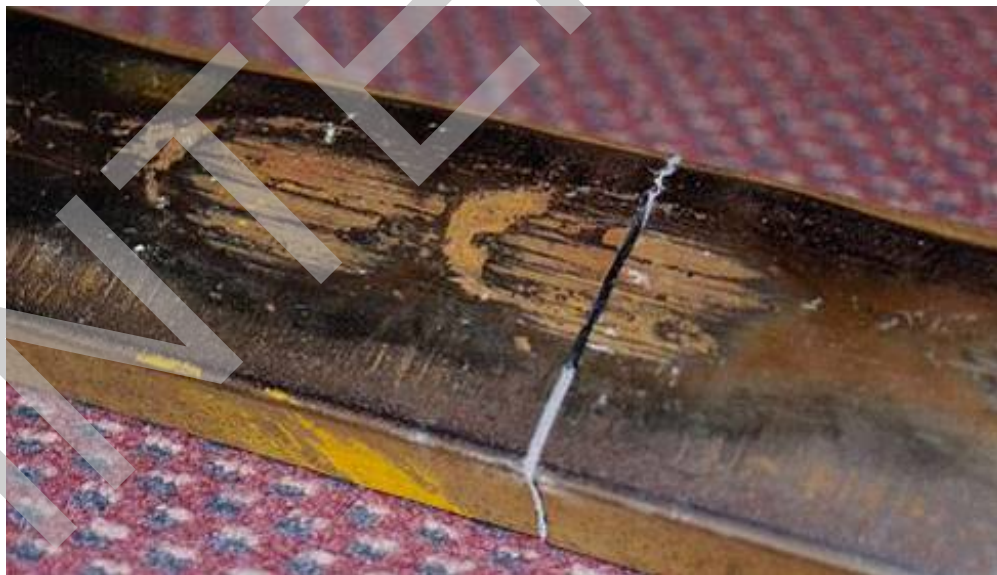
Figure 46 (a) Transverse fracture from a Wheel Burn defect

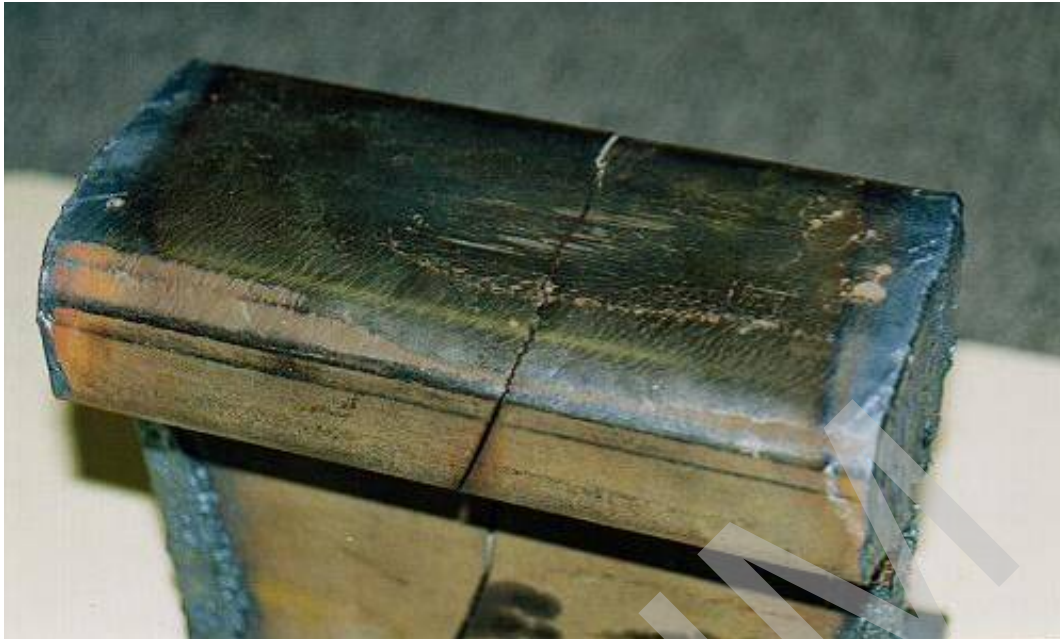
Figure 46 (b) Transverse fracture from a Wheel Burn defect

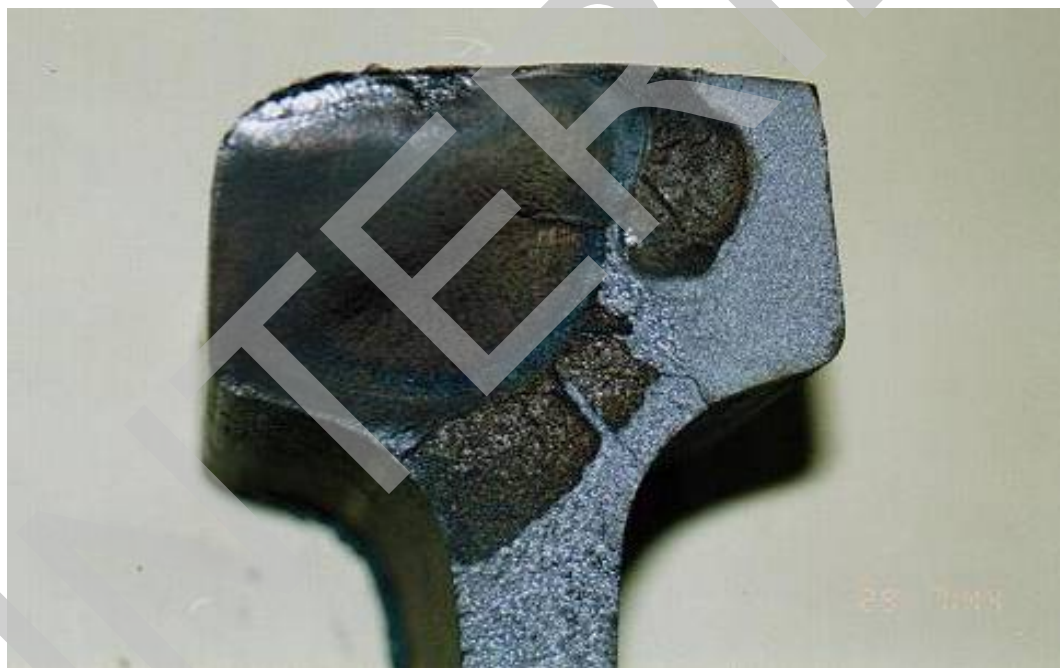
Figure 46 (c) Transverse defect initiated from a Wheel Burn defect
