# Irregular Operation of Westinghouse Releasing Switch

### Applicability

<b>Issued by</b>	<b>Date</b>
John Cowie, Manager Standards & Systems	13 April 2007

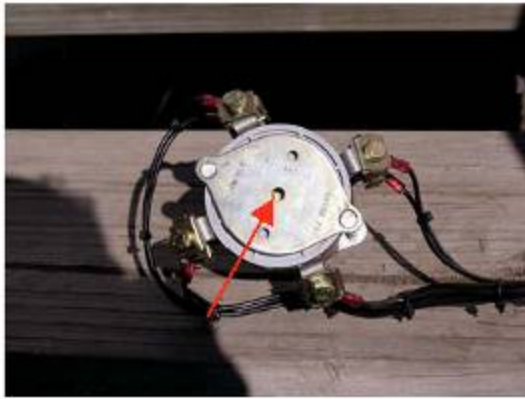
No 1

Further detailed inspection in the workshop found that there was excessive movement / play in the releasing switch handle spindle which passes through the attached lock cylinder and Santon rotary switch and allowed the ledging of the locking pin to take place. Following disassembly of the rotary switch and associated components from the case it was found that the rear bearing end of the rotary switch spindle was not engaged in the switch's rear bearing plate (No 1), thus allowing the excessive movement. Upon removal of the spindle from the switch itself it would appear that the spindle had never been fully home in the rear bearing plate from new. This was evident from the position of the keeper cap (No 2) on the spindle which prevented the spindle from travelling further into the switch and engaging into the bearing plate. Considering the above it would appear that this was a major factor in the incorrect adjustment of the lock drop contacts.

Rear of Santon switch showing spindle end not engaged in bearing plate.

- Inspect the rear of the Santon switch and ensure that the switch spindle is fully home in the bearing plate (No 3).
- Check for excessive movement in the releasing switch handle and any possibility of the locking pin ledging on the lock cylinder.
- Ensure that the lock drop contacts are open a minimum of 1mm but do not exceed 1.5mm with the locking pin sitting/ledging on the lock cylinder (No 4). Where this is not the case the bottom contact/s are to be adjusted to obtain the minimum opening.

Where it is found that the switch spindle is not fully home in the bearing plate and or the locking pin is ledging on the lock cylinder with the releasing switch handle in the 'locked' position, the complete releasing switch is to be changed out and forwarded to the Interlocking Fitters for repair. No attempt should be made to repair the releasing switch in the field.

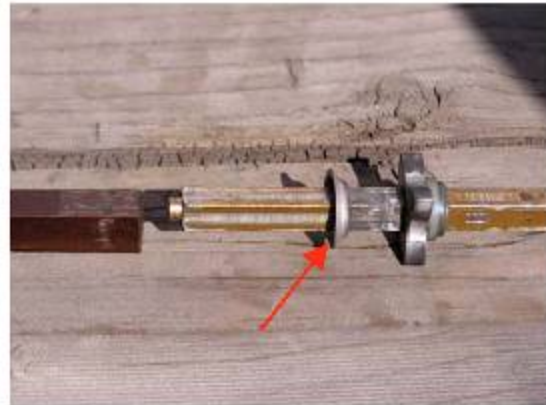
No 2

Santon Switch spindle showing incorrect position of spring keeper cap.

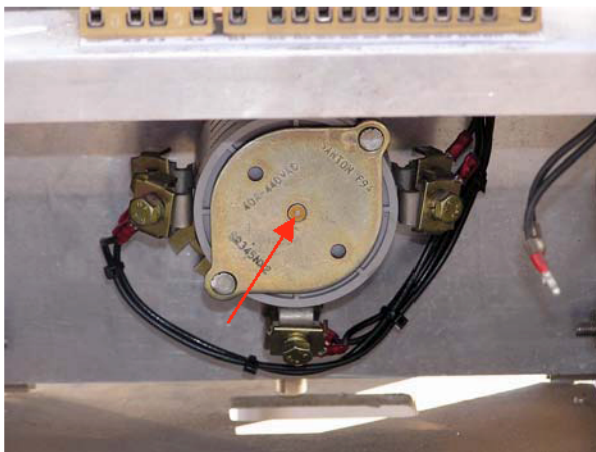
No 3

Rear of Santon switch showing spindle fully home in bearing plate.

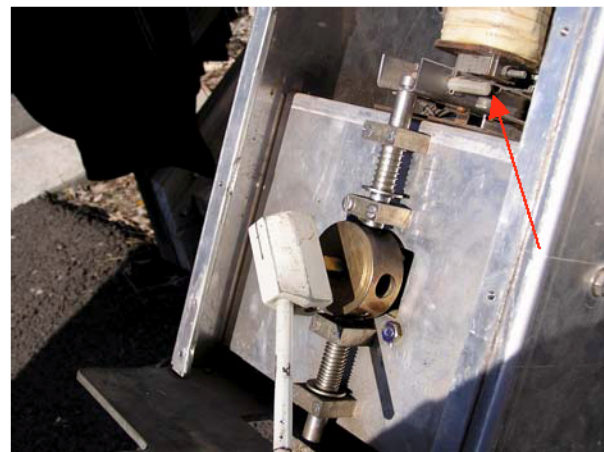
Lock drop contacts to be adjusted to a minimum opening of 1mm but not exceed 2mm with locking pin ledging on lock cylinder. No 4

1. Try to operate releasing switch handle from the 'locked' position, it should be locked.
2. Obtain / ensure release is available, then press button on releasing switch to obtain release.
3. When lock energises place handle in the 'free' position and release button to de-energise the lock.
4. Observe lock drop contacts are broken by a minimum of 1mm but do not exceed 1.5mm, (bend bottom contact to adjust).
5. Restore releasing switch handle to the 'locked' position and then try to move the handle from the 'locked' position.
