Switch Blade and Stock Rail Profiling

ETW-03-02

ARTC Network Wide
SMS

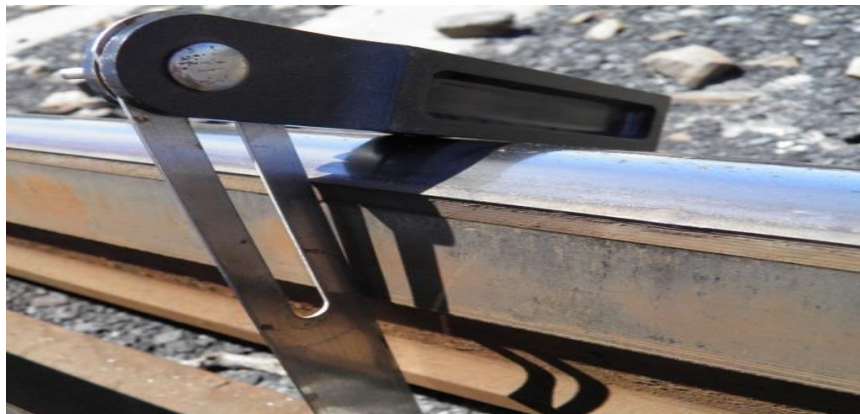
Figure 3-1: Lipping

Remove any lipping see Figure 3-1: . A sliding bevel can be used to assess the lipping. Hold the bevel against the blade. Any lipping causing a gap between the bevel and blade or stock rail should be removed.

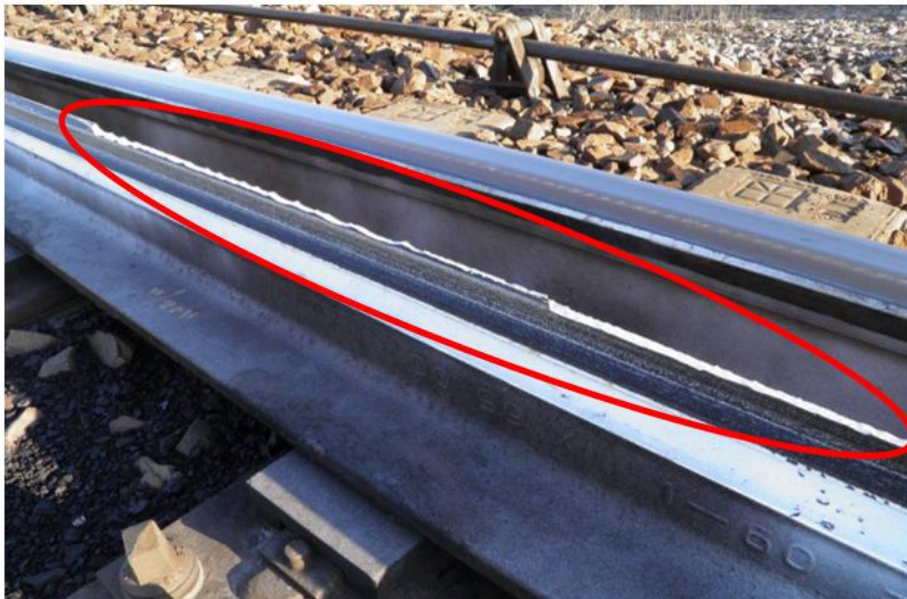
Figure 3-2: Switch blade with pieces broken away

When the rail starts to break away, the switch blade and stock rail should be ground to profile. See Figure 3-2: Switch blade with pieces broken away.

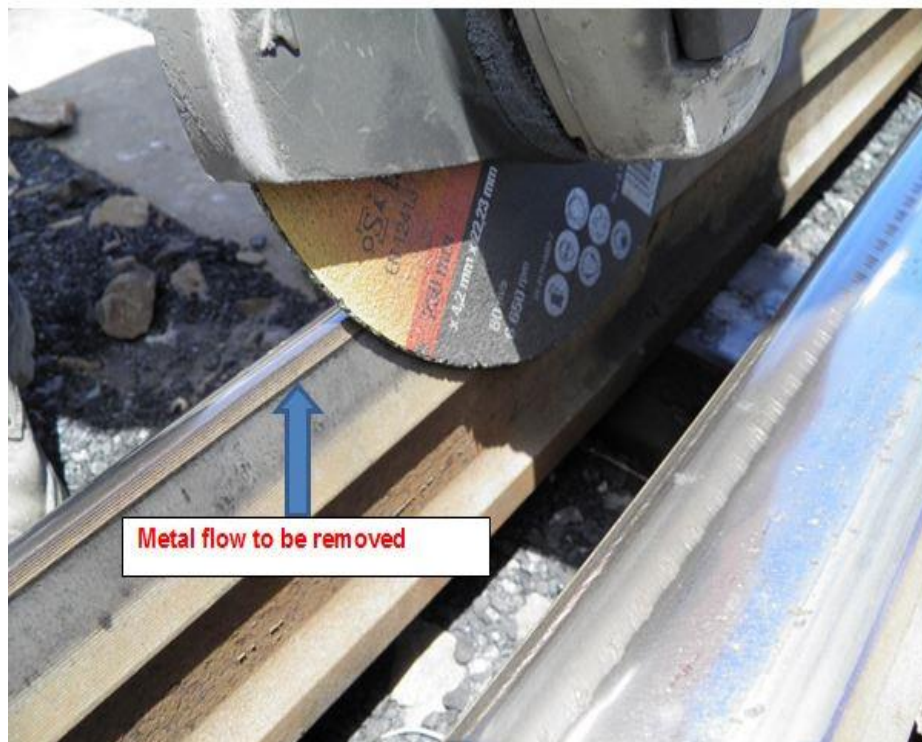
Figure 4-1: Switch blade profiling by grinder

When the switch point is worn to a thin and sharp edge, grind the edge slightly to prevent chipping or cracking of the switch point, removing only the minimum amount of steel. Refer to ARTC Track and Civil Code of Practice, Section 3 for switch and stock rail dimensioning requirements. Where grinding is undertaken using an angle grinder, care must be taken not to overheat the rail.

Remove lipping at the top edge of the back of the switch, see Figure 4-1: Switch blade profiling by grinder.

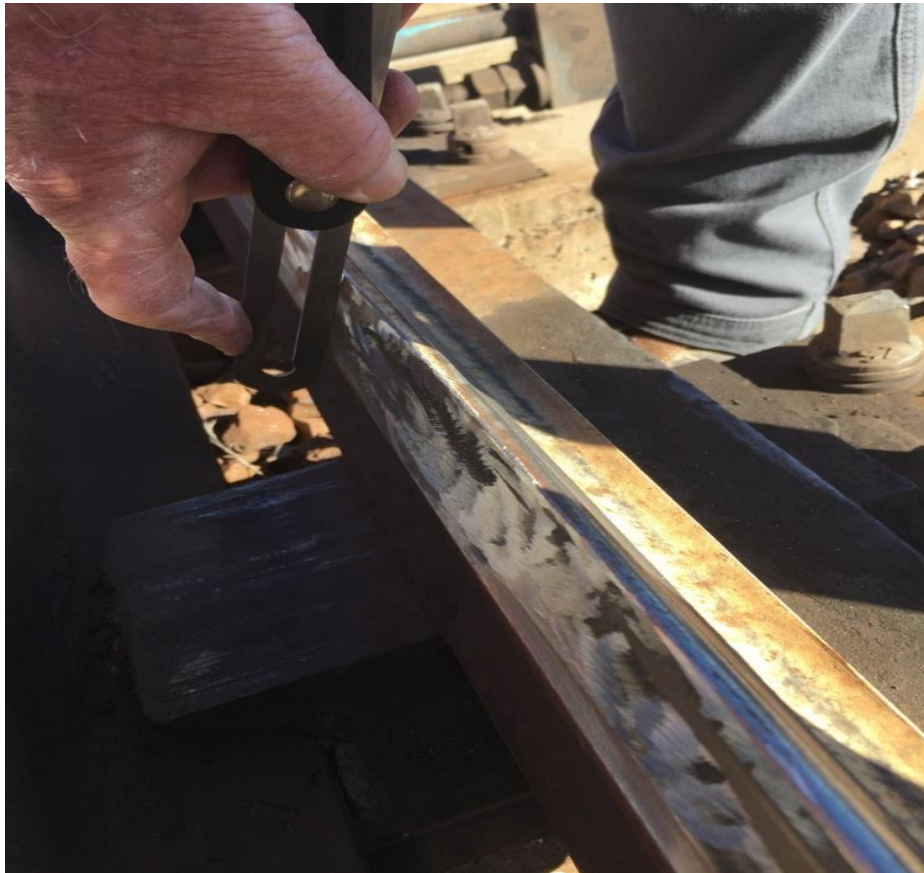
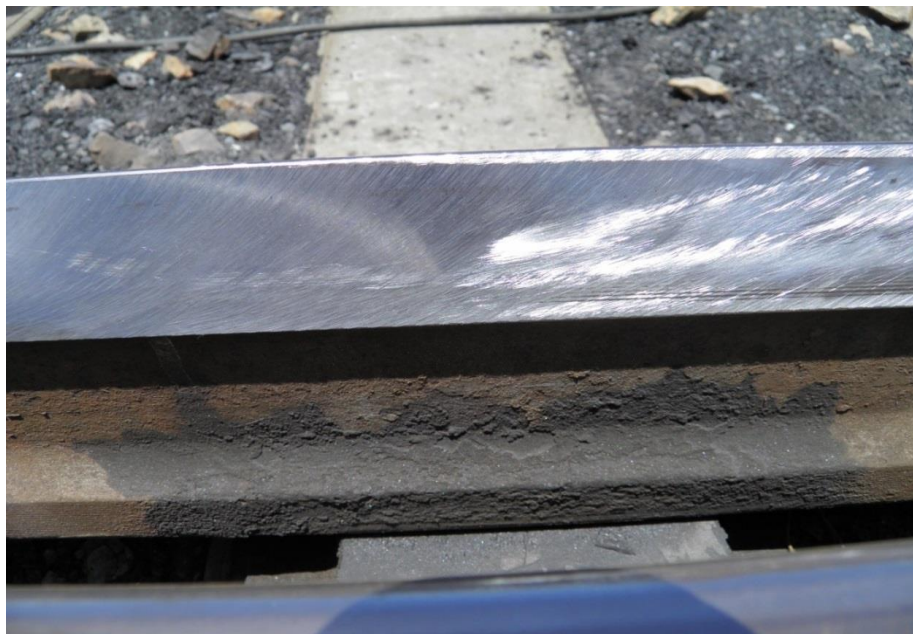
Figure 4-2: Completed profile of the switch blade

After the grinding, there should be no lipping or gap between bevel and switch or stock rail, see Figure 4-2: Completed profile of the switch blade.

To check the finished work, paint the rail top to identify tracking band and where the wheels are making contact. Check requirements against ARTC standards.
