## Mini Excavator parking procedure

The recent failure in the parking brake system on a Contractor's hired mini excavator (on an alternate network) has highlighted the need to remind operators of the need to show extreme care when parking the excavator and leaving it unattended for any period of time.

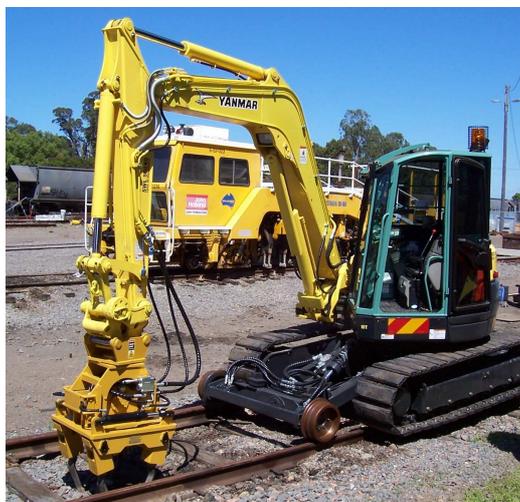
In this incident, the operator being required to leave the machine, lowered the boom to rest the attachment in the four foot and shut the machine down. Several minutes later the machine proceeded to move and run away down the gradient for 100 metres until being stopped by another employee of the contracting company.

- 1) A piece of debris was found lodged in the flow control valve, thus causing a blockage which prevented the correct application of the spring loaded parking brake.
- 2) Inefficiency in the hired hydraulic drive motors also contributed to the incident by allowing oil to drain from the motors when the machine was shut down. This leakage, although minor, was enough to allow the machine to start moving and gather momentum.

A third cause was determined to have contributed to the incident, that being the failure of the lowered boom and attachment to halt the machine's progress. It was concluded that the attachment may not have been grounded or was just sitting on a high spot of ballast, without sufficient down force to hold the machine in position.

- 1) Lower the machine to enable the rubber tracks to fully contact the rail lines.
- 2) Place the boom or attachment firmly on the ground.
- 3) Shut down the machine if leaving it for an extended period of time.

**Operators should be aware that they should immediately stand down the machine if the park brake is creeping whilst on rail and report the problem immediately to their Supervisor and Plant Coordinator.**
