2008-03 Inspection Recommendation for Aluminothermic SkV-Elite Weld Process

Audience	Main Points	Amendment Record
Delivery Managers Team Managers Ultrasonic operators	To alert operators to be aware of pronounced under head weld profile in the recently introduced Thermit SkV-Elite welds	Based on Technical Alert No. 001 from Bureau Veritas

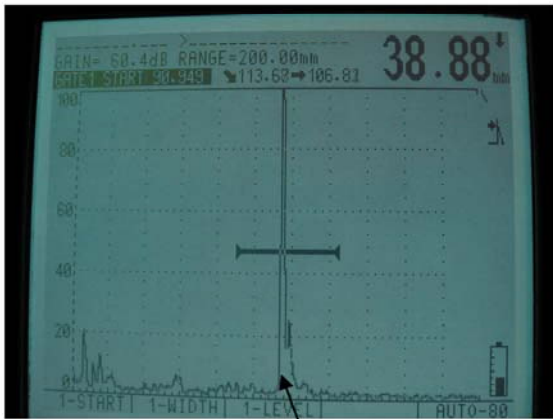
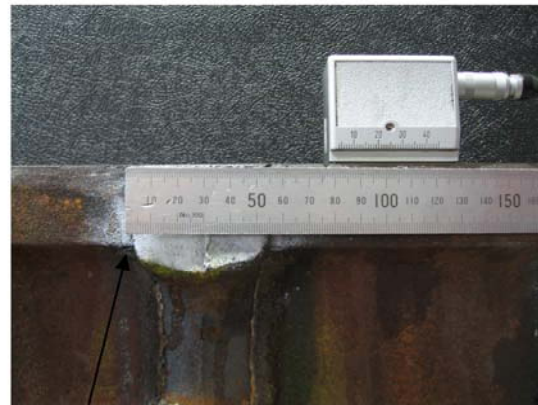
In the example on the next page the beam path of the reflection is 113mm and is coming from the underhead radius which is 106mm from the index point of the probe.

Signal received from the pronounced under head weld radius.

Simply use your 150mm rule and measure from the index point the distance in front of the probe equal to the beam path length of where the reflection is on the screen and the source of the reflection will be approximately underneath this point. If this aligns with the underhead radius on the opposite side of the weld from where your probe is this is more than likely the source of the reflection.

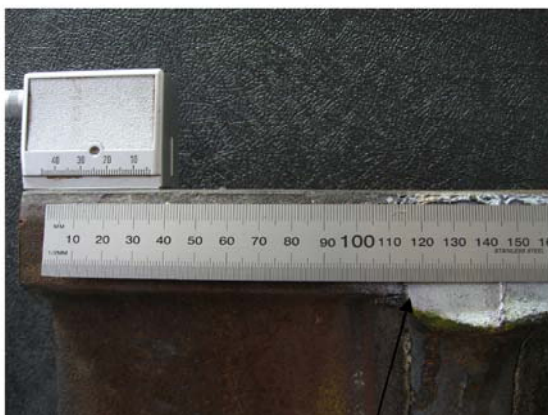
When looking at the same spot (113 from radius point). If it was a real defect then there would be a corresponding reflection at approximately 113mm. In this example there is no reflection evident. Therefore we are confident the reflection was from the underhead radius.

To make sure this is correct simply scan from the other side of the weld, if that point actually contains a defect then it will give a reflection when scanning from this side as well.
