# Switch Blade and Stock Rail Profiling

ETW-03-02

ARTC Network Wide
SMS

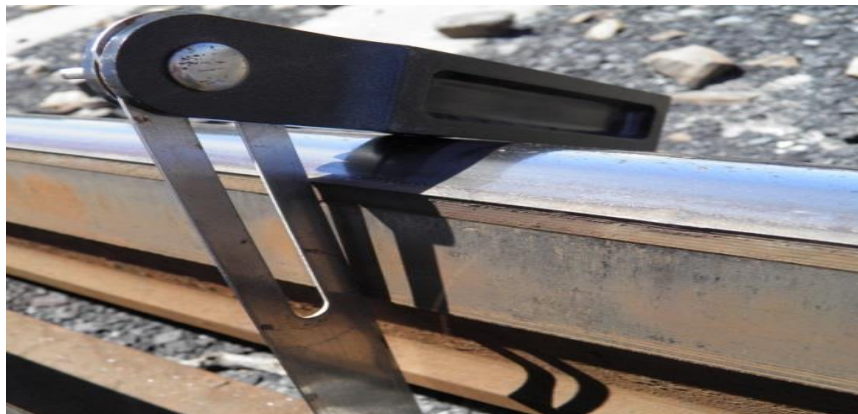
Figure 3-1: Lipping

Remove any lipping see Figure 3-1: . A sliding bevel can be used to assess the lipping. Hold the bevel against the blade. Any lipping causing a gap between the bevel and blade or stock rail should be removed.

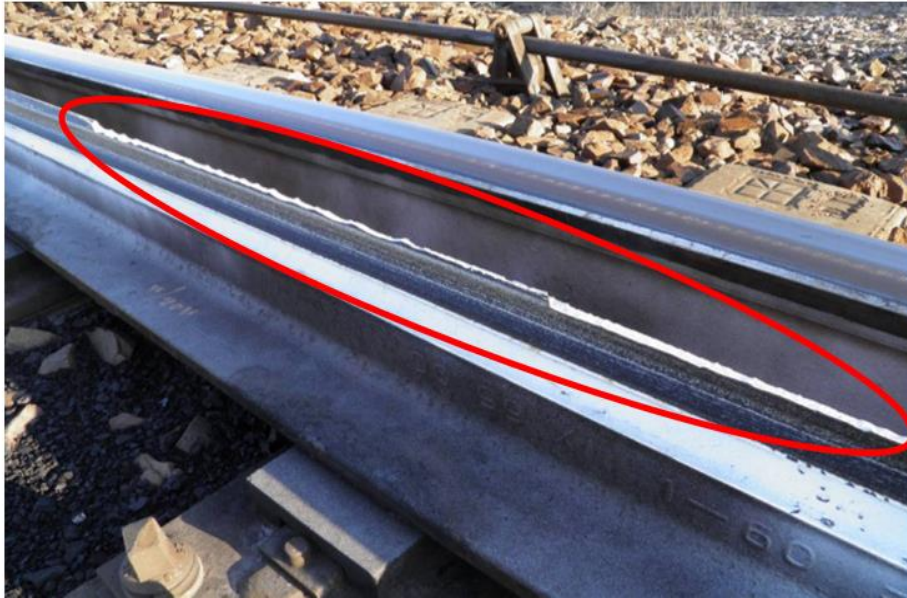
Figure 3-2: Switch blade with pieces broken away

When the rail starts to break away, the switch blade and stock rail should be ground to profile. See Figure 3-2: Switch blade with pieces broken away.

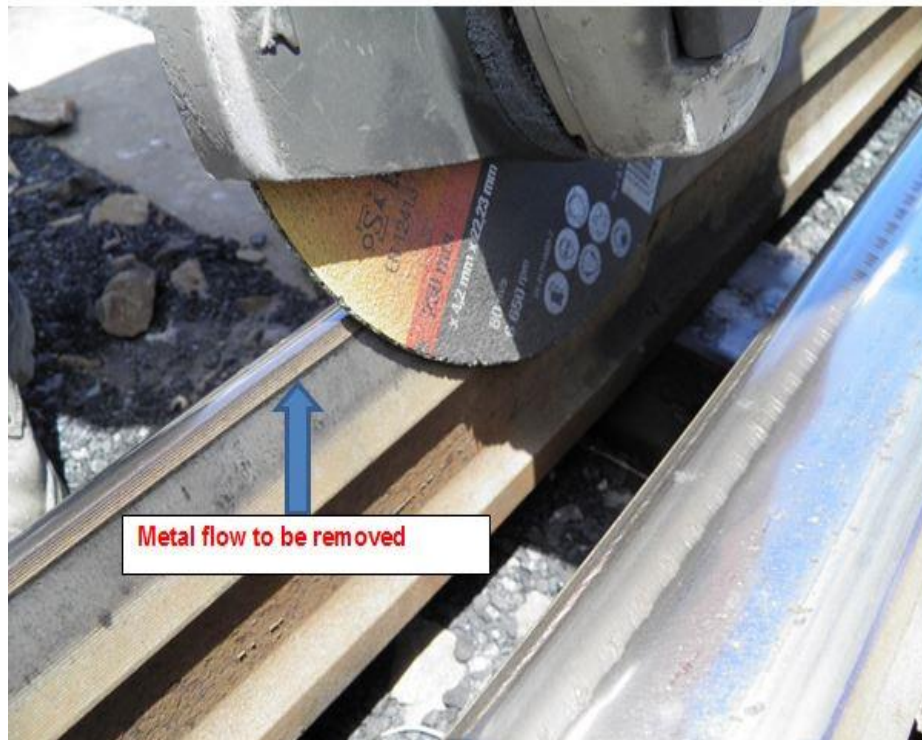
Figure 4-1: Switch blade profiling by grinder

Remove lipping at the top edge of the back of the switch, see Figure 4-1: Switch blade profiling by grinder.

When the switch point is worn to a thin and sharp edge, grind the edge slightly to prevent chipping or cracking of the switch point, removing only the minimum amount of steel. Refer to ARTC Track and Civil Code of Practice, Section 3 for switch and stock rail dimensioning requirements. Where grinding is undertaken using an angle grinder, care must be taken not to overheat the rail.

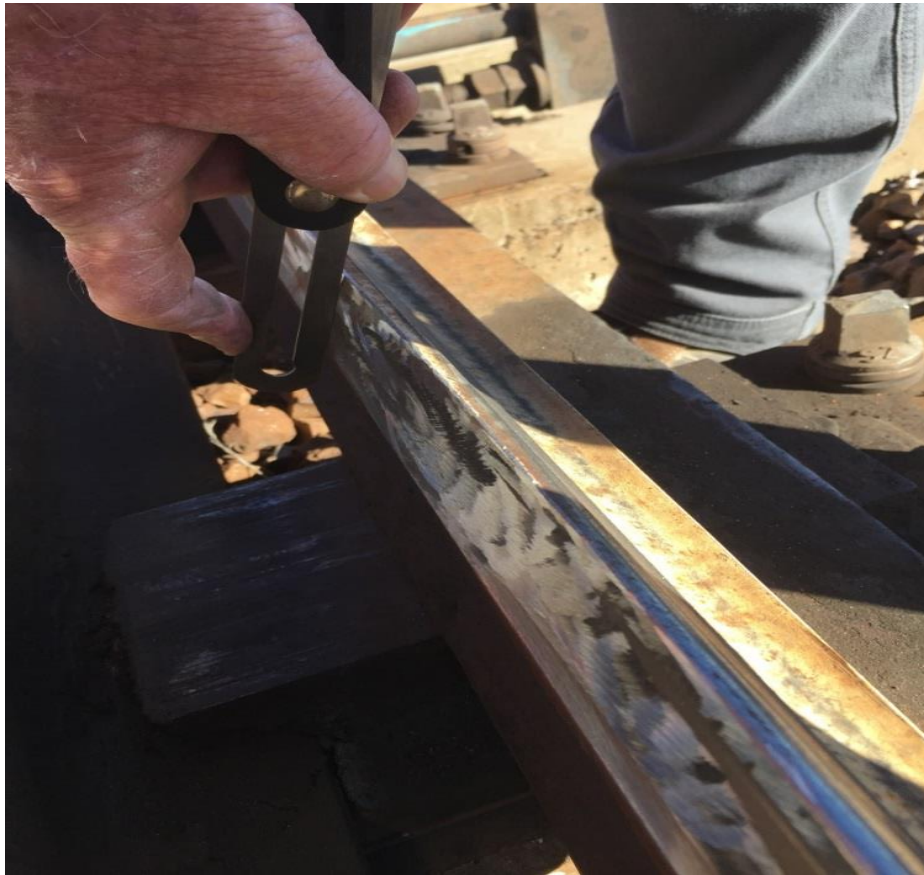
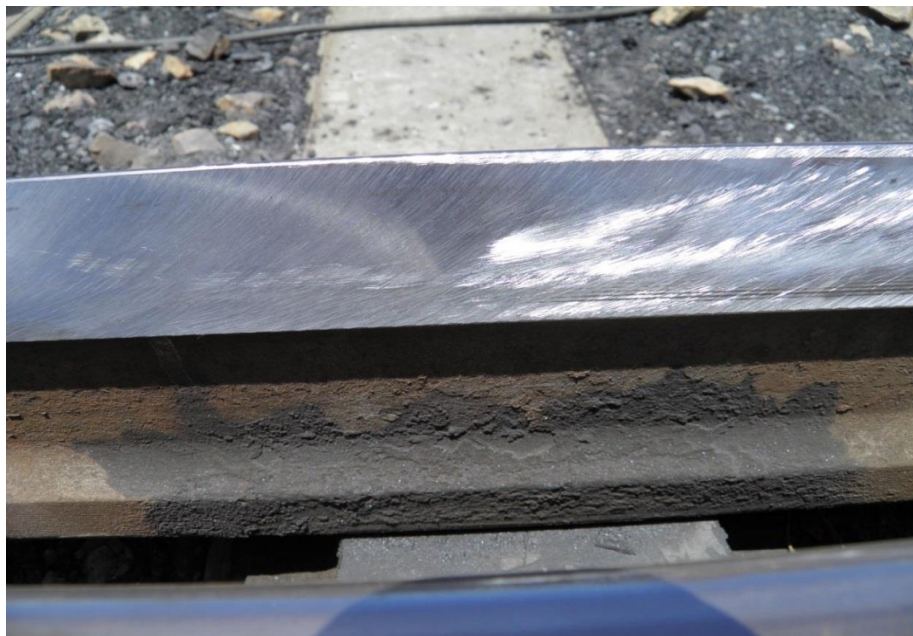
Figure 4-2: Completed profile of the switch blade

After the grinding, there should be no lipping or gap between bevel and switch or stock rail, see Figure 4-2: Completed profile of the switch blade.

To check the finished work, paint the rail top to identify tracking band and where the wheels are making contact. Check requirements against ARTC standards.
