NEW EQUIPMENT & SYSTEM APPROVAL PROFORMA

Ref: 14/28485

1 **Equipment or System to be approved ***
Track Alert System (TAS)

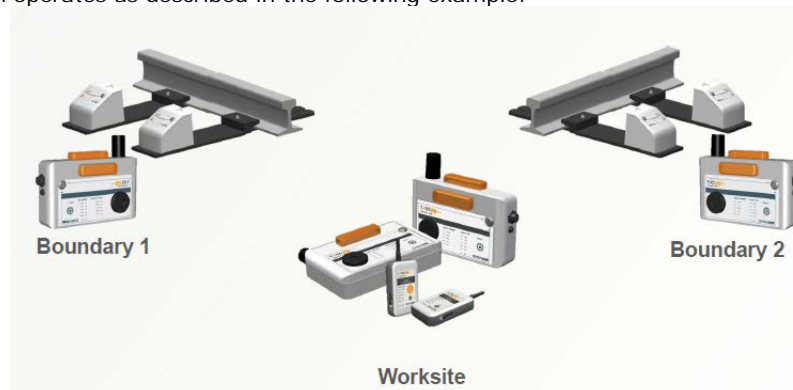
In general, the system operates as described in the following example:

1. A train or Work Vehicle passes the train detectors at Boundary 1, they detect the train or work vehicle and the repeater Unit sends a signal to the worksite.
2. At the worksite the repeater unit then receives this signal and sets off the Personal Units, the Lookout Units and the Worksite Units. They will chirp and flash and continue to do so until the vehicle has finished passing the train detectors at the Boundary.
3. As the vehicle leaves the zone and passes the detectors at Boundary 2, no alarm will sound.

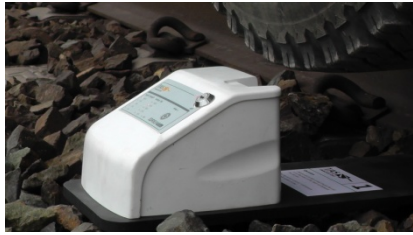
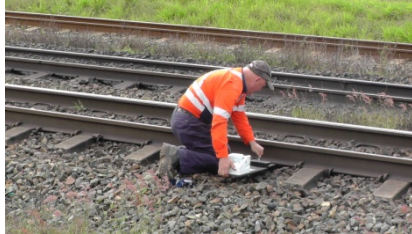
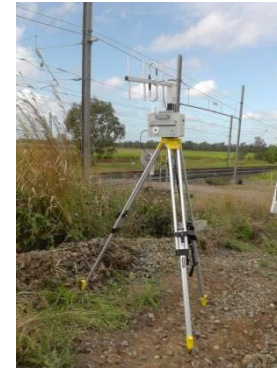
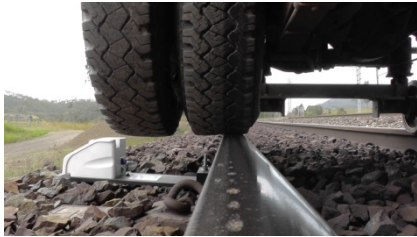
At the designated boundaries, the Train Detector slips quickly and easily under the rail. No adjustment of sensors is required for the system to operate

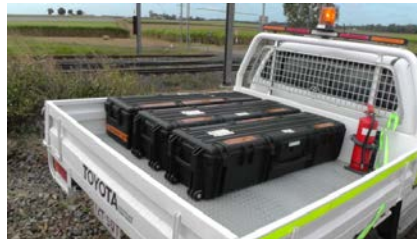
At the boundary, the repeater station is also quick and easy to set-up.

The system comes in 3 robust cases. One for each Boundary and one for the worksite.

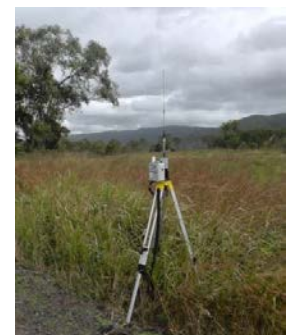
3. The Site Warning Unit sits on a tripod for visibility and audibility.
